# **GORDON PLAYGROUND INSPECTIONS LTD**

**Inspected by:** Louisa Hill

## **Annual Inspection 2020 Pucklechurch Parish Council**

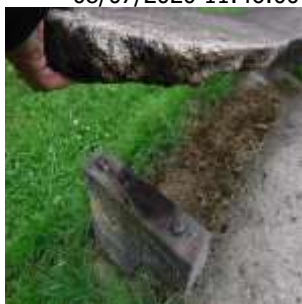
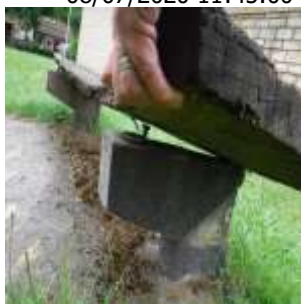
**Standard Description:** Fixtures loose or missing

Replace missing fasteners, fixtures and fitting

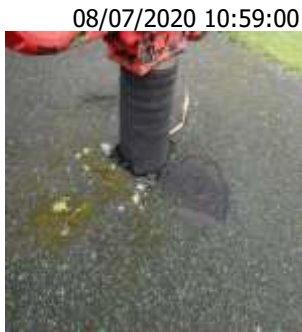
**Standard Description:** Surface wearing

Monitor

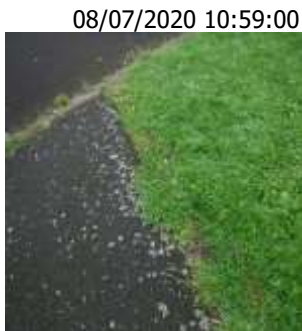
**Standard Description:** Surface has unintended weeds

Remove weeds
