Gordon Playground  
Inspections LTD **PSSLive+**

## Annual Inspection 2023

**Pucklechurch Parish Council**

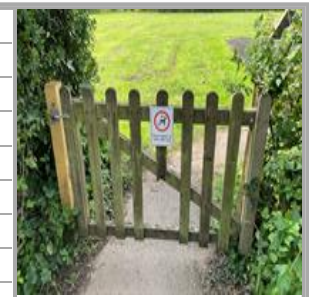
Asset Photo

<b>Asset</b>	Gate Pedestrian
<b>Finding Group</b>	Maintenance
<b>Finding Title</b>	Timber - Smashed
<b>Standard Reference</b>	
<b>Standard Description</b>	Timber - Smashed
<b>Finding Notes</b>	
<b>Cause</b>	Wear and Tear
<b>Finding Creation Date</b>	07/08/2023 13:38:14
<b>Risk Value Text</b>	1 x 2 = 2
<b>Risk Level</b>	Very Low
<b>Resolve By Date</b>	30/10/2023 12:38:35
<b>Finding Status</b>	Open

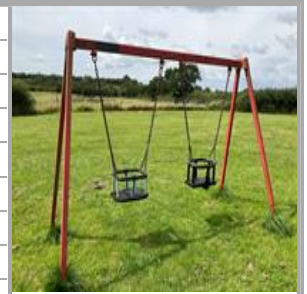
Asset Photo

<b>Asset</b>	Swing - 1 Bay Cradle Seats
<b>Finding Group</b>	Maintenance
<b>Finding Title</b>	Swing - Seat - Degrading
<b>Standard Reference</b>	
<b>Standard Description</b>	The rubber is deteriorating/degrading
<b>Finding Notes</b>	
<b>Cause</b>	Wear and Tear
<b>Finding Creation Date</b>	07/08/2023 13:44:10
<b>Risk Value Text</b>	1 x 2 = 2
<b>Risk Level</b>	Very Low
<b>Resolve By Date</b>	06/08/2024 13:44:28
<b>Finding Status</b>	Open

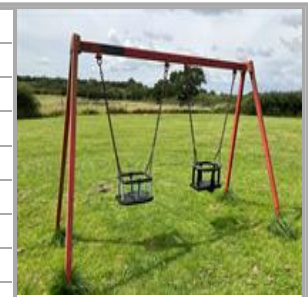
Asset Photo

<b>Asset</b>	Swing - 1 Bay Cradle Seats
<b>Finding Group</b>	Maintenance
<b>Finding Title</b>	Item - Fittings - Rusty
<b>Standard Reference</b>	
<b>Standard Description</b>	
<b>Finding Notes</b>	
<b>Cause</b>	Wear and Tear
<b>Finding Creation Date</b>	07/08/2023 13:43:41
<b>Risk Value Text</b>	1 x 1 = 1
<b>Risk Level</b>	Very Low
<b>Resolve By Date</b>	06/08/2024 13:43:52
<b>Finding Status</b>	Open

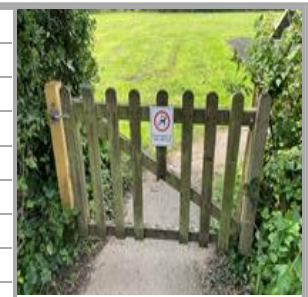
Asset Photo

<b>Asset</b>	Gate Pedestrian
<b>Finding Group</b>	BS EN 1176:2017 Part 1 (General - Playground)
<b>Finding Title</b>	Entrapment - Head & Neck
<b>Standard Reference</b>	EN 1176:2017 - 1 - 4.2.7.2
<b>Standard Description</b>	When tested in accordance with EN 1176 a head & neck entrapment is present.
<b>Finding Notes</b>	
<b>Cause</b>	Manufacturer Defect
<b>Finding Creation Date</b>	08/07/2020 13:45:00
<b>Risk Value Text</b>	1 x 3 = 3
<b>Risk Level</b>	Very Low
<b>Resolve By Date</b>	08/07/2021 13:45:00
<b>Finding Status</b>	Open

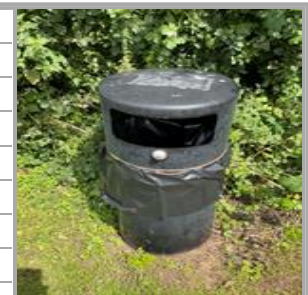
Asset Photo

<b>Asset</b>	Litter Bin
<b>Finding Group</b>	Maintenance
<b>Finding Title</b>	Item - Loose in Ground
<b>Standard Reference</b>	
<b>Standard Description</b>	Loose in ground
<b>Finding Notes</b>	
<b>Cause</b>	Installation Defect
<b>Finding Creation Date</b>	08/07/2020 13:45:00
<b>Risk Value Text</b>	1 x 2 = 2
<b>Risk Level</b>	Very Low
<b>Resolve By Date</b>	07/01/2021 13:45:00
<b>Finding Status</b>	Open

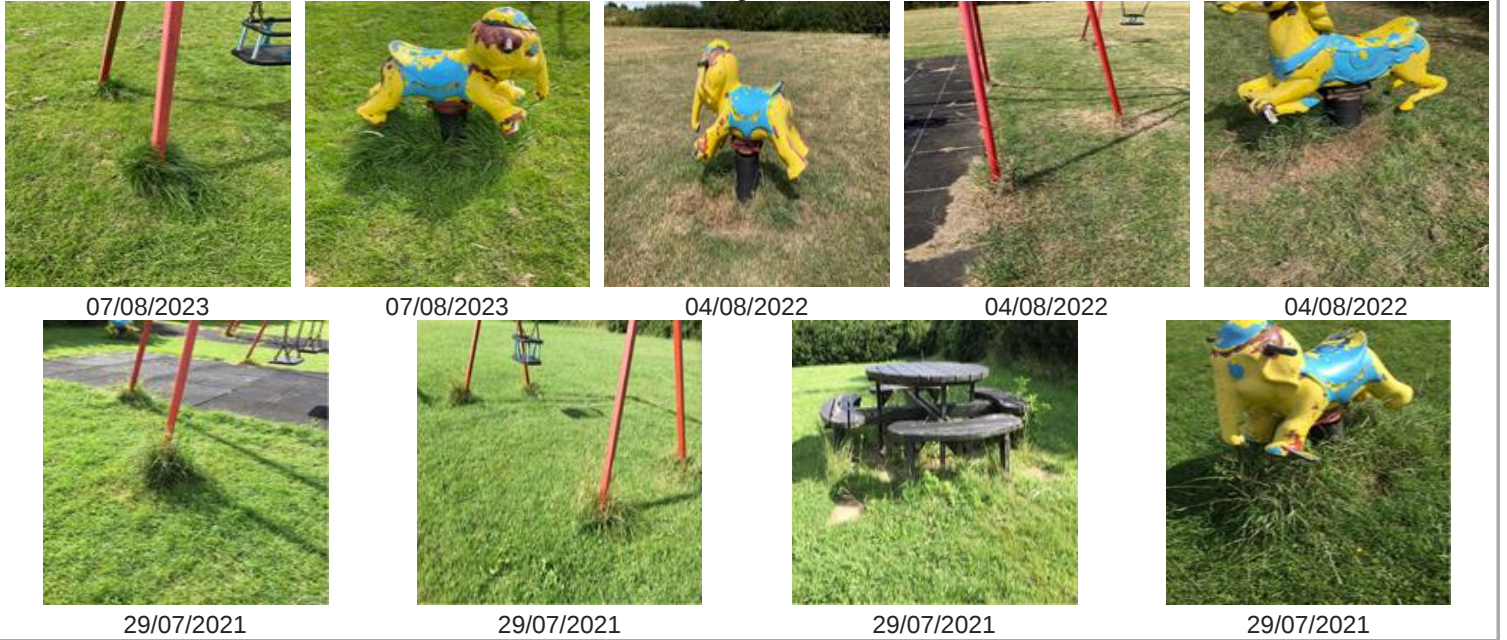
## Grass - Requires Mowing/Cutting - Task

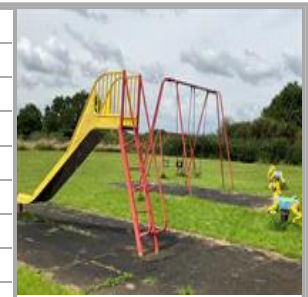
Asset Photo

<b>Asset</b>	Site - Shortwood
<b>Finding Group</b>	Maintenance
<b>Finding Title</b>	Surface - Weeds
<b>Standard Reference</b>	
<b>Standard Description</b>	Surface has unintended weeds
<b>Finding Notes</b>	
<b>Cause</b>	Routine
<b>Finding Creation Date</b>	08/07/2020 13:45:00
<b>Risk Value Text</b>	1 x 2 = 2
<b>Risk Level</b>	Very Low
<b>Resolve By Date</b>	07/01/2021 13:45:00
<b>Finding Status</b>	Open

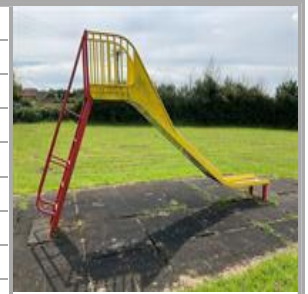
Asset Photo

<b>Asset</b>	Slide Free Standing
<b>Finding Group</b>	Maintenance
<b>Finding Title</b>	Item - Rusting in places
<b>Standard Reference</b>	
<b>Standard Description</b>	Item is rusting in places
<b>Finding Notes</b>	Bar under slide runout
<b>Cause</b>	Wear and Tear
<b>Finding Creation Date</b>	25/07/2022 12:50:00
<b>Risk Value Text</b>	1 x 1 = 1
<b>Risk Level</b>	Very Low
<b>Resolve By Date</b>	25/07/2023 12:50:00
<b>Finding Status</b>	Open

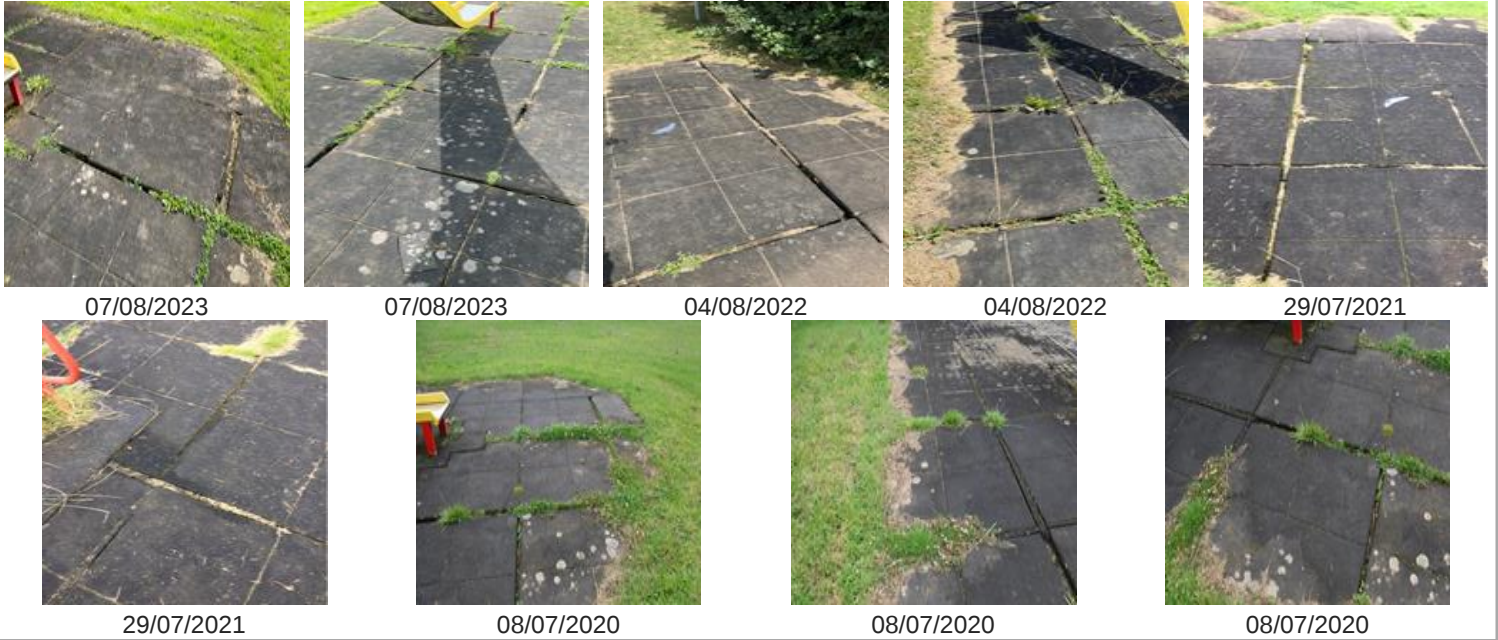
### Surface - Tiles - Gaps - Task

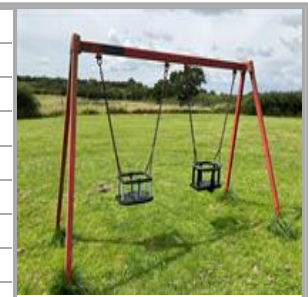
Asset Photo

<b>Asset</b>	Swing - 1 Bay Cradle Seats
<b>Finding Group</b>	Maintenance
<b>Finding Title</b>	Chain - Links Worn
<b>Standard Reference</b>	
<b>Standard Description</b>	Chains links worn
<b>Finding Notes</b>	
<b>Cause</b>	Wear and Tear
<b>Finding Creation Date</b>	08/07/2020 13:45:00
<b>Risk Value Text</b>	1 x 3 = 3
<b>Risk Level</b>	Very Low
<b>Resolve By Date</b>	08/07/2021 13:45:00
<b>Finding Status</b>	Open

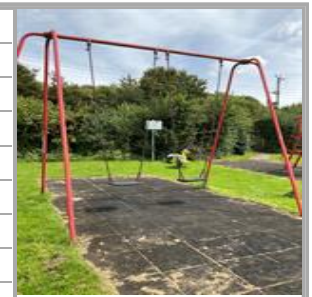
Asset Photo

<b>Asset</b>	Swing - 1 Bay Flat Seats
<b>Finding Group</b>	Maintenance
<b>Finding Title</b>	Chain - Cruxiform Connector(s) Worn
<b>Standard Reference</b>	
<b>Standard Description</b>	The cruxiform chain connector is worn.
<b>Finding Notes</b>	
<b>Cause</b>	Wear and Tear
<b>Finding Creation Date</b>	08/07/2020 13:45:00
<b>Risk Value Text</b>	1 x 3 = 3
<b>Risk Level</b>	Very Low
<b>Resolve By Date</b>	07/01/2021 13:45:00
<b>Finding Status</b>	Open

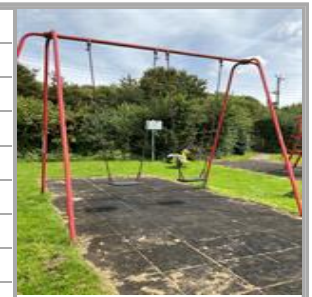
Asset Photo

<b>Asset</b>	Swing - 1 Bay Flat Seats
<b>Finding Group</b>	Maintenance
<b>Finding Title</b>	Chain - Links Worn
<b>Standard Reference</b>	
<b>Standard Description</b>	Chains links worn
<b>Finding Notes</b>	
<b>Cause</b>	Wear and Tear
<b>Finding Creation Date</b>	08/07/2020 13:45:00
<b>Risk Value Text</b>	1 x 3 = 3
<b>Risk Level</b>	Very Low
<b>Resolve By Date</b>	08/07/2021 13:45:00
<b>Finding Status</b>	Open

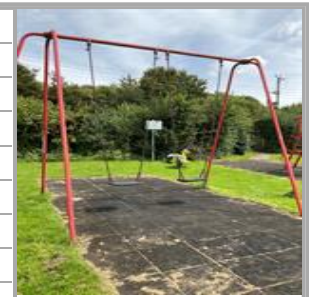
Asset Photo

<b>Asset</b>	Swing - 1 Bay Flat Seats
<b>Finding Group</b>	Maintenance
<b>Finding Title</b>	Fixtures - Loose or Missing
<b>Standard Reference</b>	
<b>Standard Description</b>	Fixtures loose or missing
<b>Finding Notes</b>	
<b>Cause</b>	Wear and Tear
<b>Finding Creation Date</b>	08/07/2020 13:45:00
<b>Risk Value Text</b>	2 x 4 = 8
<b>Risk Level</b>	Low
<b>Resolve By Date</b>	08/10/2020 13:45:00
<b>Finding Status</b>	Open

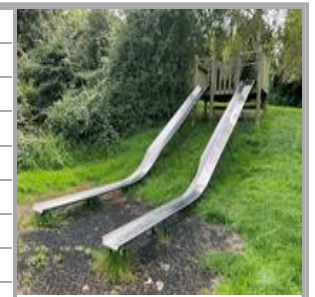
Asset Photo

<b>Asset</b>	Multiplay Unit Junior
<b>Finding Group</b>	Maintenance
<b>Finding Title</b>	Item - Bent
<b>Standard Reference</b>	
<b>Standard Description</b>	Item is bent
<b>Finding Notes</b>	
<b>Cause</b>	Vandalism
<b>Finding Creation Date</b>	07/08/2023 14:29:22
<b>Risk Value Text</b>	1 x 1 = 1
<b>Risk Level</b>	Very Low
<b>Resolve By Date</b>	06/08/2024 14:29:39
<b>Finding Status</b>	Open

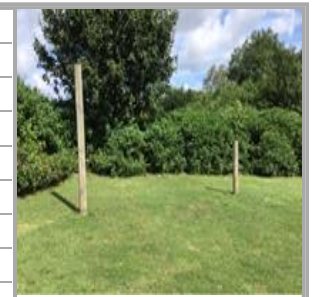
Asset Photo

<b>Asset</b>	Goal Posts
<b>Finding Group</b>	Maintenance
<b>Finding Title</b>	Timber - New Wide Cracks
<b>Standard Reference</b>	
<b>Standard Description</b>	Timber new wide cracks
<b>Finding Notes</b>	
<b>Cause</b>	Wear and Tear
<b>Finding Creation Date</b>	08/07/2020 13:15:00
<b>Risk Value Text</b>	1 x 1 = 1
<b>Risk Level</b>	Very Low
<b>Resolve By Date</b>	08/07/2021 13:15:00
<b>Finding Status</b>	Open

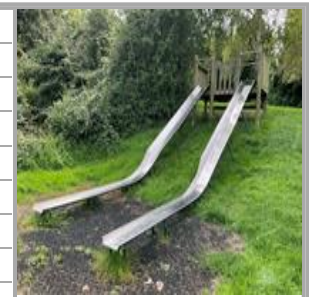
Asset Photo

<b>Asset</b>	Multiplay Unit Junior
<b>Finding Group</b>	Maintenance
<b>Finding Title</b>	Timber - Rotting
<b>Standard Reference</b>	
<b>Standard Description</b>	Timber rotting
<b>Finding Notes</b>	
<b>Cause</b>	Wear and Tear
<b>Finding Creation Date</b>	29/07/2021 10:55:31
<b>Risk Value Text</b>	1 x 1 = 1
<b>Risk Level</b>	Very Low
<b>Resolve By Date</b>	29/07/2022 10:55:50
<b>Finding Status</b>	Open

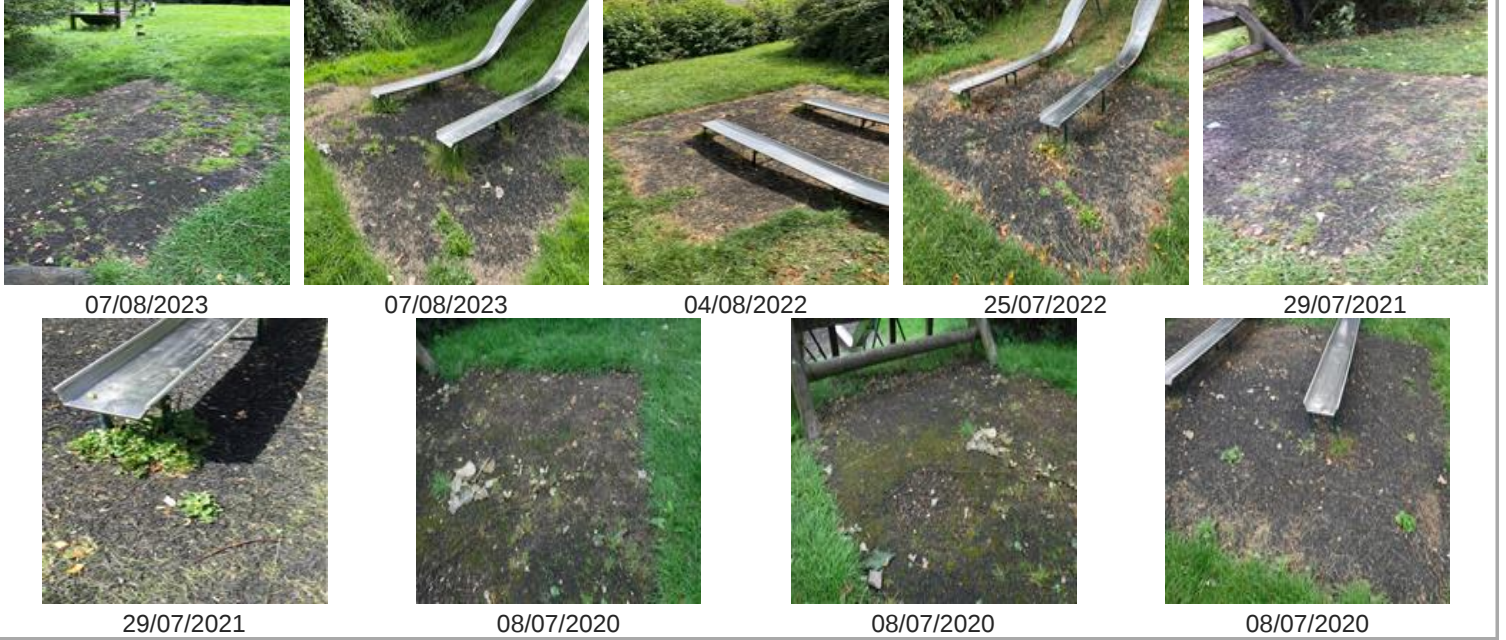
Surface - Weeds - Task

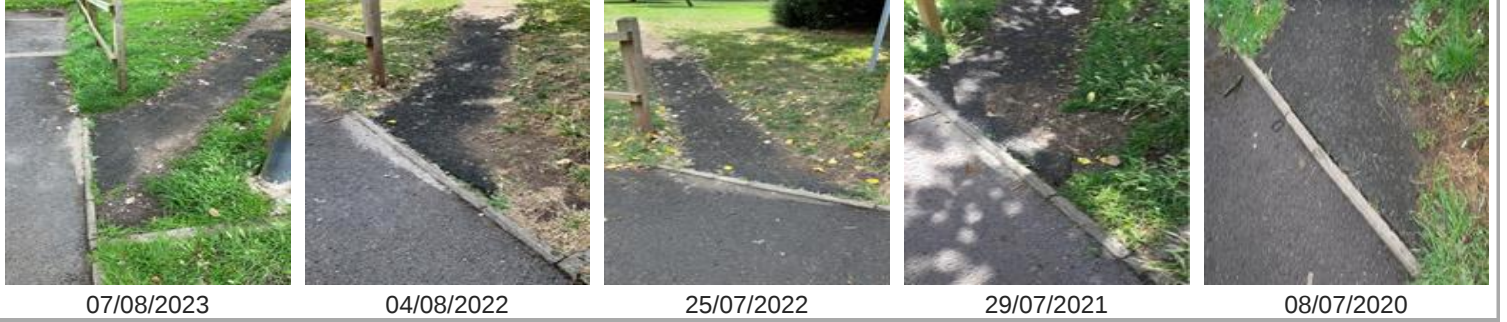
**Surface - Trip points - Task**

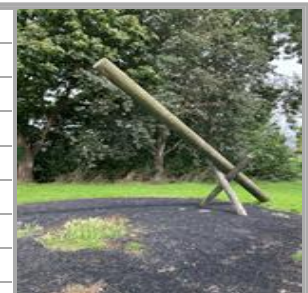
Asset Photo

<b>Asset</b>	Swing - Single Point
<b>Finding Group</b>	Maintenance
<b>Finding Title</b>	Swing - Seats - Missing
<b>Standard Reference</b>	
<b>Standard Description</b>	Swing seats missing
<b>Finding Notes</b>	
<b>Cause</b>	Wear and Tear
<b>Finding Creation Date</b>	08/07/2020 13:15:00
<b>Risk Value Text</b>	1 x 1 = 1
<b>Risk Level</b>	Very Low
<b>Resolve By Date</b>	08/10/2020 13:15:00
<b>Finding Status</b>	Open

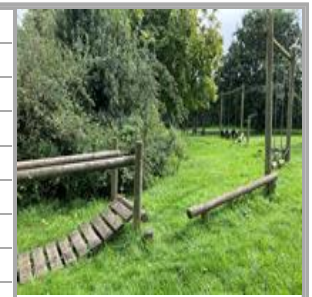
Asset Photo

<b>Asset</b>	Trim Trail
<b>Finding Group</b>	Maintenance
<b>Finding Title</b>	Timber - Strimmer Damage
<b>Standard Reference</b>	
<b>Standard Description</b>	The timber has been damaged during grass cutting works.
<b>Finding Notes</b>	
<b>Cause</b>	Poor Maintenance
<b>Finding Creation Date</b>	29/07/2021 11:01:02
<b>Risk Value Text</b>	1 x 1 = 1
<b>Risk Level</b>	Very Low
<b>Resolve By Date</b>	13/01/2022 11:01:24
<b>Finding Status</b>	Open

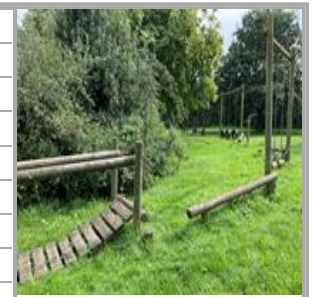
Asset Photo

Asset	Trim Trail
Finding Group	Maintenance
Finding Title	Chain - Connectors Worn
Standard Reference	
Standard Description	Chain link connectors worn
Finding Notes	
Cause	Wear and Tear
Finding Creation Date	08/07/2020 13:15:00
Risk Value Text	1 x 3 = 3
Risk Level	Very Low
Resolve By Date	08/07/2021 13:15:00
Finding Status	Open

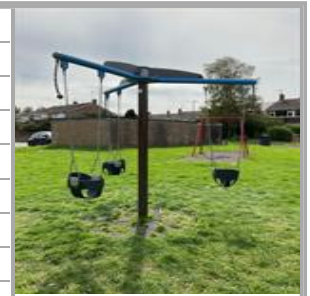
Asset Photo

<b>Asset</b>	Carousel Overhead 3 Cradle Seat
<b>Finding Group</b>	Maintenance
<b>Finding Title</b>	Item - Cap missing
<b>Standard Reference</b>	
<b>Standard Description</b>	Item - Cap missing
<b>Finding Notes</b>	
<b>Cause</b>	Wear and Tear
<b>Finding Creation Date</b>	07/08/2023 15:06:00
<b>Risk Value Text</b>	1 x 1 = 1
<b>Risk Level</b>	Very Low
<b>Resolve By Date</b>	07/02/2024 15:06:00
<b>Finding Status</b>	Open

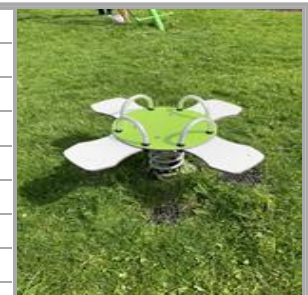
Asset Photo

<b>Asset</b>	Rocker Daisy
<b>Finding Group</b>	Maintenance
<b>Finding Title</b>	Fixtures - Loose or Missing
<b>Standard Reference</b>	
<b>Standard Description</b>	Fixtures loose or missing
<b>Finding Notes</b>	1 fixing missing
<b>Cause</b>	Wear and Tear
<b>Finding Creation Date</b>	07/08/2023 15:06:00
<b>Risk Value Text</b>	4 x 3 = 12
<b>Risk Level</b>	Medium
<b>Resolve By Date</b>	21/08/2023 15:06:00
<b>Finding Status</b>	Open

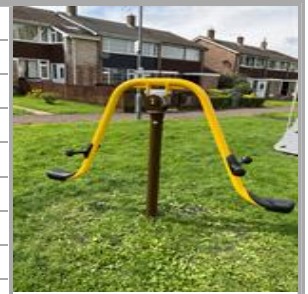
Asset Photo

<b>Asset</b>	Rocker Rotator (Mini)
<b>Finding Group</b>	Maintenance
<b>Finding Title</b>	Item - Rusting in places
<b>Standard Reference</b>	
<b>Standard Description</b>	Item is rusting in places
<b>Finding Notes</b>	
<b>Cause</b>	Wear and Tear
<b>Finding Creation Date</b>	07/08/2023 15:06:00
<b>Risk Value Text</b>	1 x 1 = 1
<b>Risk Level</b>	Very Low
<b>Resolve By Date</b>	07/02/2024 15:06:00
<b>Finding Status</b>	Open

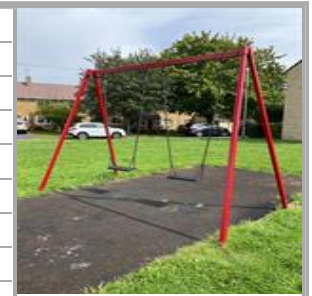
Asset Photo

<b>Asset</b>	Swing - 1 Bay Flat Seat
<b>Finding Group</b>	Maintenance
<b>Finding Title</b>	Chain - Links Worn
<b>Standard Reference</b>	
<b>Standard Description</b>	Chains links worn
<b>Finding Notes</b>	
<b>Cause</b>	Wear and Tear
<b>Finding Creation Date</b>	07/08/2023 15:06:00
<b>Risk Value Text</b>	1 x 3 = 3
<b>Risk Level</b>	Very Low
<b>Resolve By Date</b>	07/08/2024 15:06:00
<b>Finding Status</b>	Open

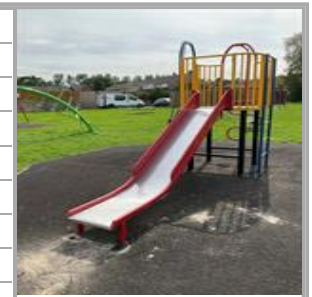
Asset Photo

<b>Asset</b>	Multiplay Unit Junior
<b>Finding Group</b>	Maintenance
<b>Finding Title</b>	Chain - Links Worn
<b>Standard Reference</b>	
<b>Standard Description</b>	Chain links notched
<b>Finding Notes</b>	
<b>Cause</b>	Wear and Tear
<b>Finding Creation Date</b>	08/07/2020 12:45:00
<b>Risk Value Text</b>	1 x 3 = 3
<b>Risk Level</b>	Very Low
<b>Resolve By Date</b>	08/07/2021 12:45:00
<b>Finding Status</b>	Open

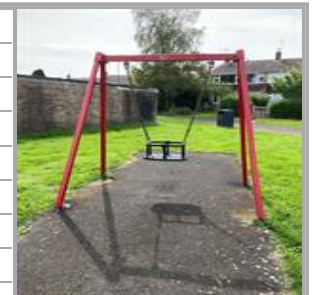
Asset Photo

<b>Asset</b>	Swing - 1 Bay Cradle Seat
<b>Finding Group</b>	Maintenance
<b>Finding Title</b>	Chain - Links Worn
<b>Standard Reference</b>	
<b>Standard Description</b>	Chains links worn
<b>Finding Notes</b>	
<b>Cause</b>	Wear and Tear
<b>Finding Creation Date</b>	08/07/2020 12:45:00
<b>Risk Value Text</b>	1 x 3 = 3
<b>Risk Level</b>	Very Low
<b>Resolve By Date</b>	08/07/2021 12:45:00
<b>Finding Status</b>	Open

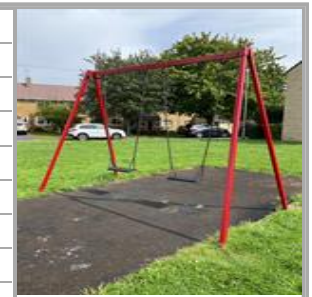
Asset Photo

<b>Asset</b>	Swing - 1 Bay Flat Seat
<b>Finding Group</b>	Maintenance
<b>Finding Title</b>	Fixtures - Loose or Missing
<b>Standard Reference</b>	
<b>Standard Description</b>	Fixtures loose or missing
<b>Finding Notes</b>	
<b>Cause</b>	Wear and Tear
<b>Finding Creation Date</b>	08/07/2020 12:45:00
<b>Risk Value Text</b>	2 x 4 = 8
<b>Risk Level</b>	Low
<b>Resolve By Date</b>	08/10/2020 12:45:00
<b>Finding Status</b>	Open

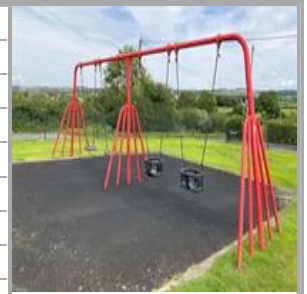
Asset Photo

<b>Asset</b>	Swing - 2 Bay Mixed Seat
<b>Finding Group</b>	Maintenance
<b>Finding Title</b>	Item - Fittings - Rusty
<b>Standard Reference</b>	
<b>Standard Description</b>	
<b>Finding Notes</b>	
<b>Cause</b>	Wear and Tear
<b>Finding Creation Date</b>	07/08/2023 15:44:20
<b>Risk Value Text</b>	1 x 1 = 1
<b>Risk Level</b>	Very Low
<b>Resolve By Date</b>	06/08/2024 15:44:40
<b>Finding Status</b>	Open

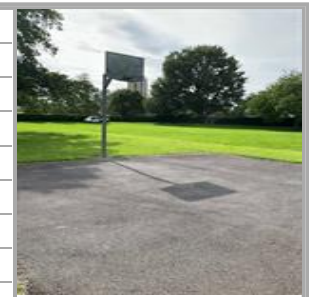
Asset Photo

<b>Asset</b>	Basketball Post
<b>Finding Group</b>	Maintenance
<b>Finding Title</b>	Item - Damaged
<b>Standard Reference</b>	
<b>Standard Description</b>	Item is damaged
<b>Finding Notes</b>	Backboard insert
<b>Cause</b>	Wear and Tear
<b>Finding Creation Date</b>	08/07/2020 12:13:00
<b>Risk Value Text</b>	1 x 1 = 1
<b>Risk Level</b>	Very Low
<b>Resolve By Date</b>	08/07/2021 12:13:00
<b>Finding Status</b>	Open

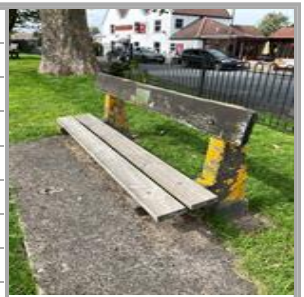
Asset Photo

<b>Asset</b>	Bench - Seats x18
<b>Finding Group</b>	Maintenance
<b>Finding Title</b>	Timber - Not in Good Condition
<b>Standard Reference</b>	
<b>Standard Description</b>	Timber condition
<b>Finding Notes</b>	07.08.23 Condition deteriorated
<b>Cause</b>	Wear and Tear
<b>Finding Creation Date</b>	29/07/2021 12:08:12
<b>Risk Value Text</b>	1 x 1 = 1
<b>Risk Level</b>	Very Low
<b>Resolve By Date</b>	13/01/2022 12:08:50
<b>Finding Status</b>	Open

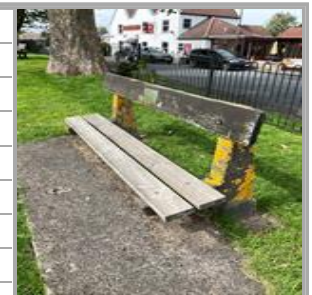
Asset Photo

<b>Asset</b>	Bench - Seats x18
<b>Finding Group</b>	Maintenance
<b>Finding Title</b>	Metal - Excessive Corrosion
<b>Standard Reference</b>	
<b>Standard Description</b>	Metal excessive corrosion
<b>Finding Notes</b>	
<b>Cause</b>	Wear and Tear
<b>Finding Creation Date</b>	29/07/2021 11:45:03
<b>Risk Value Text</b>	1 x 2 = 2
<b>Risk Level</b>	Very Low
<b>Resolve By Date</b>	29/07/2022 11:45:41
<b>Finding Status</b>	Open

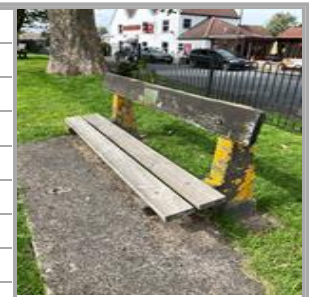
Asset Photo

<b>Asset</b>	Bench - Seats x18
<b>Finding Group</b>	Maintenance
<b>Finding Title</b>	Fixtures - Loose or Missing
<b>Standard Reference</b>	
<b>Standard Description</b>	Fixtures loose or missing
<b>Finding Notes</b>	
<b>Cause</b>	Wear and Tear
<b>Finding Creation Date</b>	29/07/2021 11:44:25
<b>Risk Value Text</b>	1 x 3 = 3
<b>Risk Level</b>	Very Low
<b>Resolve By Date</b>	13/01/2022 11:44:50
<b>Finding Status</b>	Open

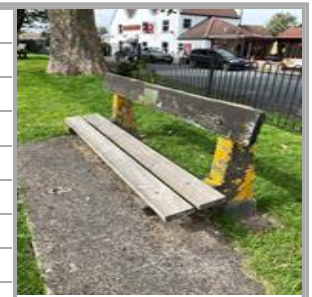
Asset Photo

<b>Asset</b>	Bench - Seats x18
<b>Finding Group</b>	Maintenance
<b>Finding Title</b>	Timber - Not in Good Condition
<b>Standard Reference</b>	
<b>Standard Description</b>	Timber condition
<b>Finding Notes</b>	25.07.22 Condition deteriorated 07.08.23 Condition deteriorated further
<b>Cause</b>	Wear and Tear
<b>Finding Creation Date</b>	29/07/2021 11:43:21
<b>Risk Value Text</b>	2 x 2 = 4
<b>Risk Level</b>	Low
<b>Resolve By Date</b>	30/10/2023 14:37:18
<b>Finding Status</b>	Open

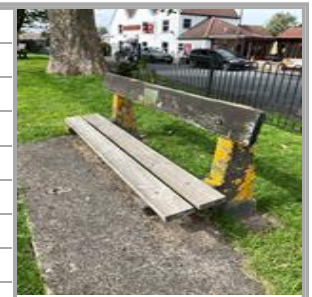
Asset Photo

<b>Asset</b>	Bench - Seats x18
<b>Finding Group</b>	Maintenance
<b>Finding Title</b>	Ground Eroded
<b>Standard Reference</b>	
<b>Standard Description</b>	Ground eroded
<b>Finding Notes</b>	
<b>Cause</b>	Wear and Tear
<b>Finding Creation Date</b>	29/07/2021 11:39:30
<b>Risk Value Text</b>	1 x 3 = 3
<b>Risk Level</b>	Very Low
<b>Resolve By Date</b>	13/01/2022 11:39:44
<b>Finding Status</b>	Open

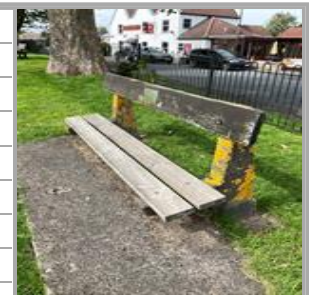
Asset Photo

<b>Asset</b>	Bench - Seats x18
<b>Finding Group</b>	Maintenance
<b>Finding Title</b>	Fixtures - Loose or Missing
<b>Standard Reference</b>	
<b>Standard Description</b>	Fixtures loose or missing
<b>Finding Notes</b>	Fixing loose throughout seat and metal part missing from one end
<b>Cause</b>	Wear and Tear
<b>Finding Creation Date</b>	08/07/2020 12:13:00
<b>Risk Value Text</b>	2 x 2 = 4
<b>Risk Level</b>	Low
<b>Resolve By Date</b>	08/10/2020 12:13:00
<b>Finding Status</b>	Open

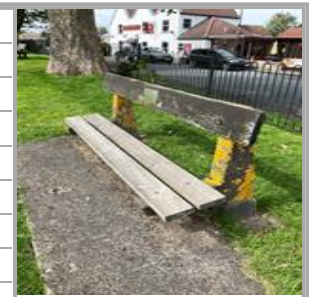
Asset Photo

<b>Asset</b>	Bench - Seats x18
<b>Finding Group</b>	Maintenance
<b>Finding Title</b>	Fixtures - Loose or Missing
<b>Standard Reference</b>	
<b>Standard Description</b>	Fixtures loose or missing
<b>Finding Notes</b>	
<b>Cause</b>	Wear and Tear
<b>Finding Creation Date</b>	08/07/2020 12:13:00
<b>Risk Value Text</b>	1 x 2 = 2
<b>Risk Level</b>	Very Low
<b>Resolve By Date</b>	08/10/2020 12:13:00
<b>Finding Status</b>	Open

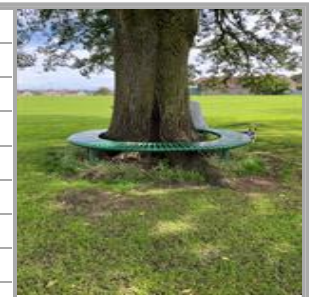
Asset Photo

<b>Asset</b>	Bench - Tree Seat
<b>Finding Group</b>	Maintenance
<b>Finding Title</b>	Ground Eroded
<b>Standard Reference</b>	
<b>Standard Description</b>	Ground eroded
<b>Finding Notes</b>	
<b>Cause</b>	Wear and Tear
<b>Finding Creation Date</b>	08/07/2020 12:13:00
<b>Risk Value Text</b>	2 x 3 = 6
<b>Risk Level</b>	Low
<b>Resolve By Date</b>	08/10/2020 12:13:00
<b>Finding Status</b>	Open

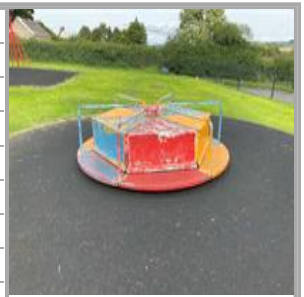
Asset Photo

<b>Asset</b>	Carousel
<b>Finding Group</b>	Maintenance
<b>Finding Title</b>	Metal - Excessive Corrosion
<b>Standard Reference</b>	
<b>Standard Description</b>	Metal excessive corrosion
<b>Finding Notes</b>	
<b>Cause</b>	Wear and Tear
<b>Finding Creation Date</b>	08/07/2020 12:13:00
<b>Risk Value Text</b>	2 x 4 = 8
<b>Risk Level</b>	Low
<b>Resolve By Date</b>	08/10/2020 12:13:00
<b>Finding Status</b>	Open
