**Gordon Playground  
Inspections LTD PSSLive<sup>+</sup>**

## **Annual Inspection 2024**

**Eagle Crescent Play Area**

**Pucklechurch Parish Council**

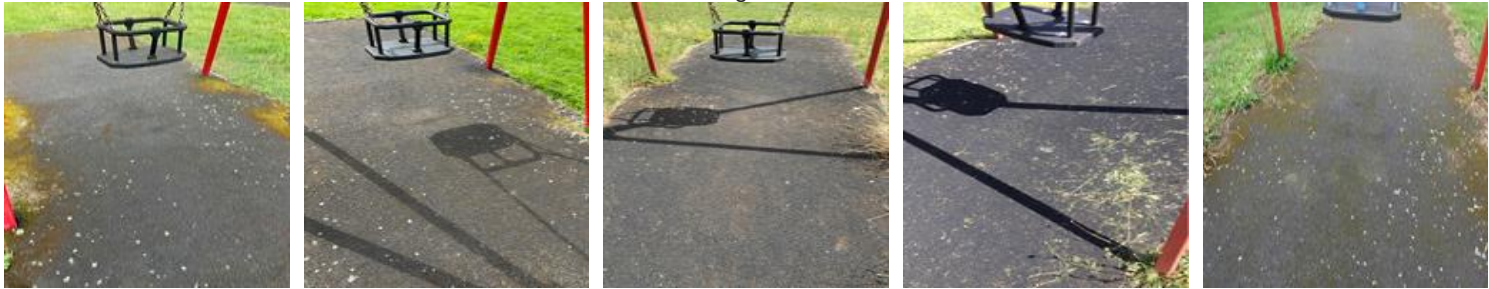
Asset	Swing - 1 Bay Cradle Seat - Surface
Finding Group	Maintenance
Finding Title	Surface - Wearing
Standard Reference	
Standard Description	Surface wearing
Finding Notes	
Cause	Wear and Tear
Finding Creation Date	08/07/2020 12:45:00
Risk Value Text	1 x 1 = 1
Risk Level	Very Low
Resolve By Date	08/07/2021 12:45:00
Finding Status	Open

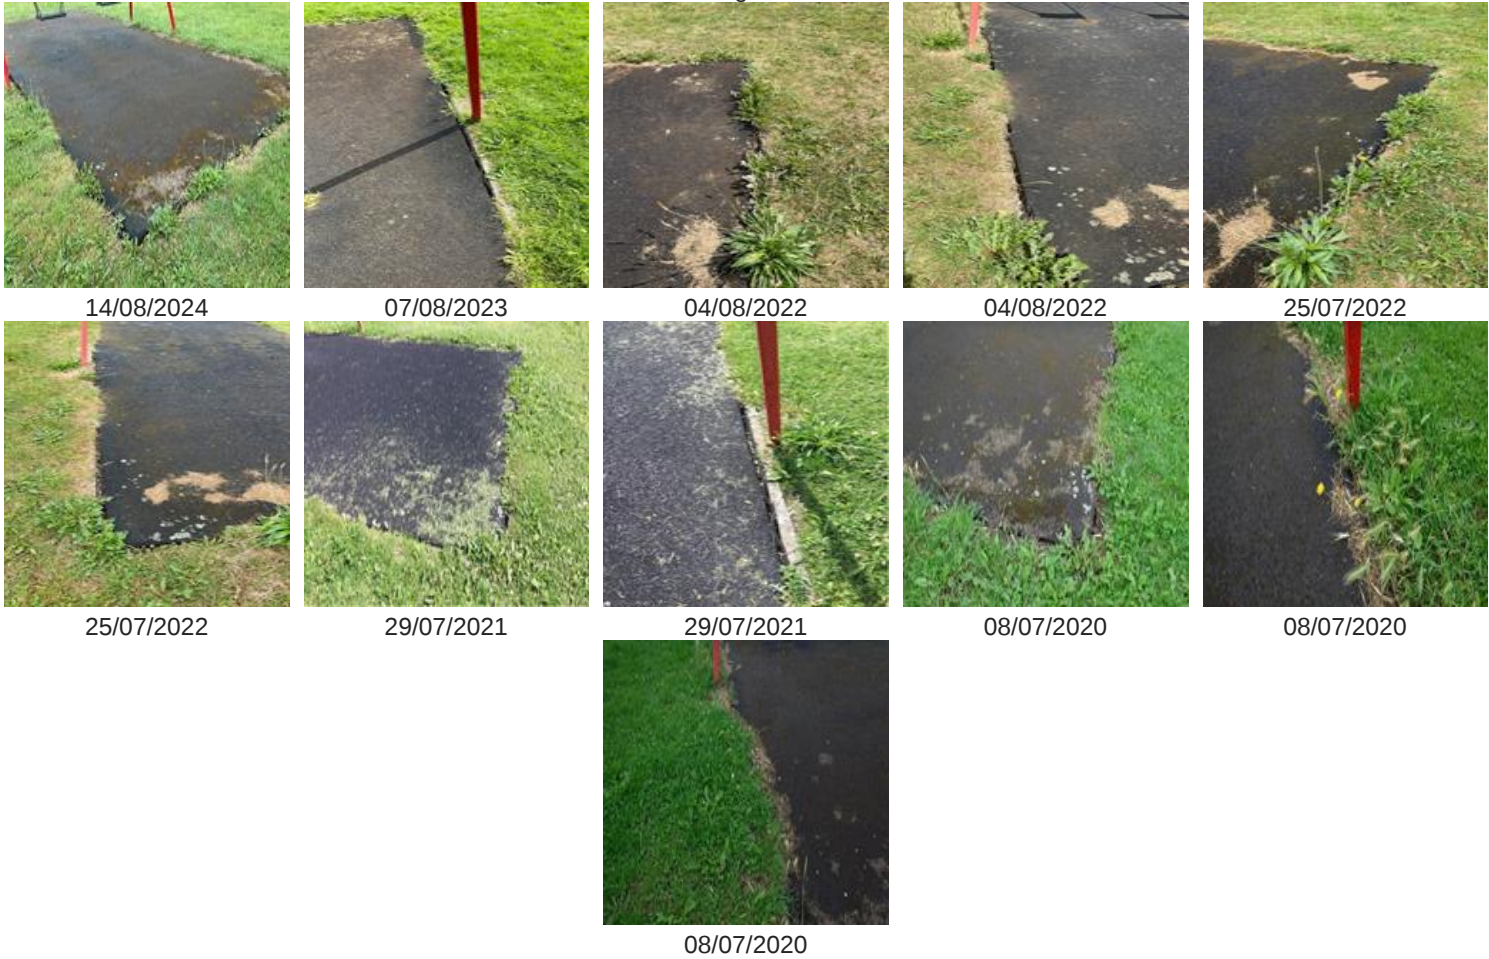
Asset	Swing - 1 Bay Flat Seat - Surface
Finding Group	Maintenance
Finding Title	Surface - Edges Shrunk
Standard Reference	
Standard Description	The edges of the safer surface are curling and are a trip hazard
Finding Notes	25.07.22 Condition deteriorated 14.08.24 Condition deteriorated further
Cause	Wear and Tear
Finding Creation Date	08/07/2020 12:45:00
Risk Value Text	3 x 3 = 9
Risk Level	Low
Resolve By Date	07/01/2021 12:45:00
Finding Status	Open

Surface - Edges Shrunk - Task

Task Title	Repair edges
Task Notes	
Task Status	Unapproved
