Gordon Playground
Inspections LTD **PSSLive+**

Annual Inspection 2024

Parkfield Play Area

Pucklechurch Parish Council

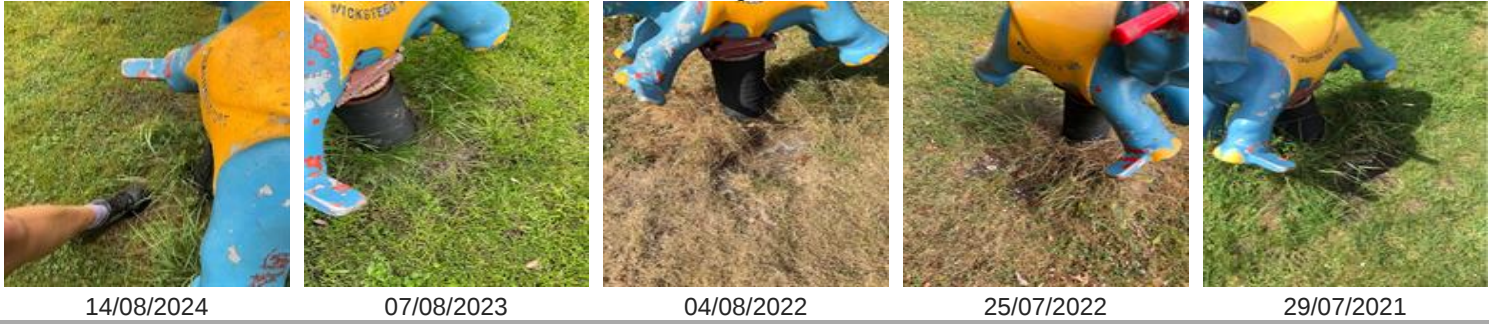
Asset	Rocker Elephant - Surface
Finding Group	Maintenance
Finding Title	Ground Eroded
Standard Reference	
Standard Description	Ground eroded
Finding Notes	
Cause	Wear and Tear
Finding Creation Date	29/07/2021 13:03:32
Risk Value Text	1 x 2 = 2
Risk Level	Very Low
Resolve By Date	13/01/2022 13:03:46
Finding Status	Open

Task Title	Make good surface
Task Notes	
Task Status	Unapproved
