Pucklechurch Parish Burial Ground

Area Assessment and Memorial report – July 2021

Pucklechurch Burial Ground - Overview

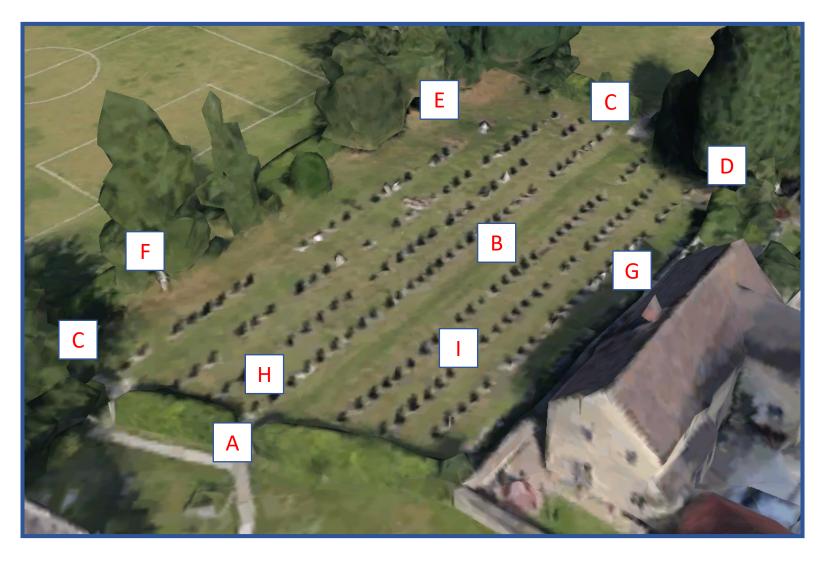
General Info.	Hazards
A – Entrance from Churchyard	Overgrown bushes and brambles
<mark>B</mark> – Main walkway / footpaths	Uneven surface in many areas
C – Exits onto Recreation ground	Gates missing or unable to latch
D – Water standpipe	Frost protection / Leak control
E – Memorial Bench	Overgrown bushes and litter
F – Holly Bushes	Overhanging and obstructing access route
G – Old stone wall	Damage in one area
H – Memorial D33	One memorial failed "wobble test"
I – Other memorials	Passed "wobble test" but require monitoring

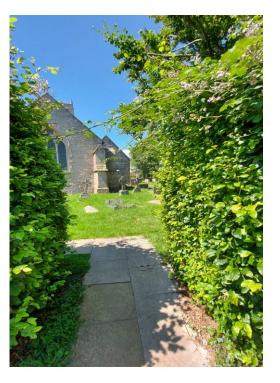
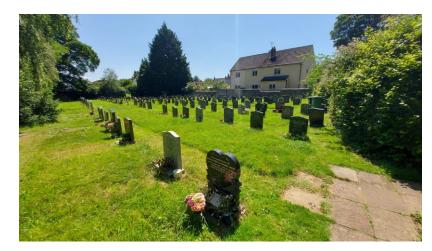
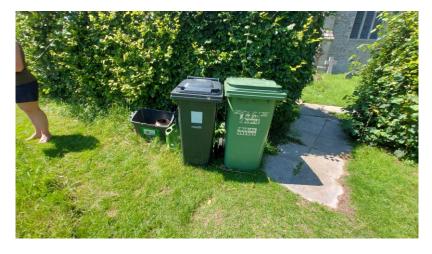
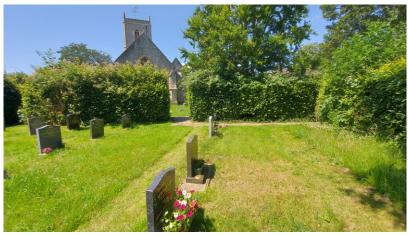
A – Entrance from Churchyard

- The entrance from the churchyard consists of an access route with no gate but high bushes on either side which contain some bramble.
- Several movable waste bins are located in this area.
- Signage for dog walkers is hidden when walking in certain directions.

- Cut bramble back and trim bushes to ensure safe access.
- Improve signage for "Dogs on leads"
- Relocate bins to better area so they do not cause an obstruction.

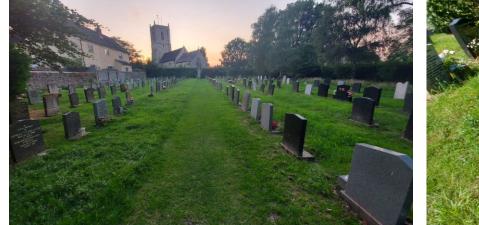
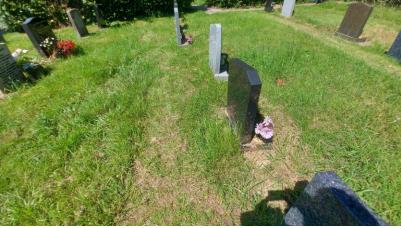
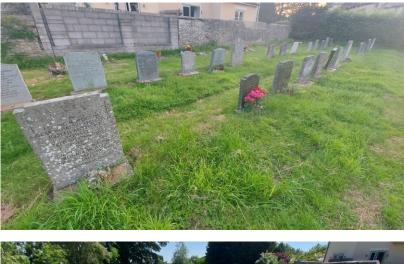
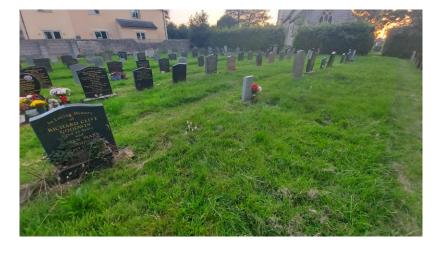
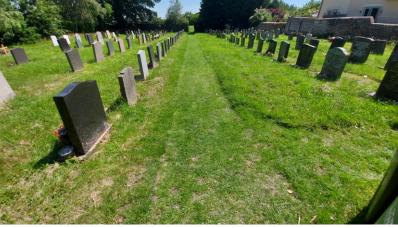
B – Main footpaths and Access Routes

- The routes are made up of cut grassed pathways
- Some of the routes are uneven and difficult to identify any hazard within the surface
- There are unidentified small potholes within the routes

- Ask contractor to identify any areas which are potential trip / fall hazards
- Ask contractor to begin program of levelling some of these identified areas.
- Maintain program of grass cutting to reduce risk
- Identify methods of separating pathways to ensure visitors keep to identified routes.

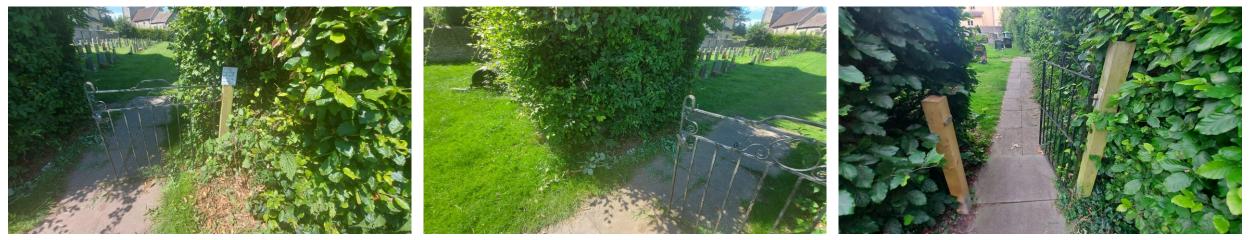
C – Exits onto Recreation Ground

- Two exits / access routes onto the recreation ground
- Both routes have gates although the exit at the Church end of the burial ground does not latch.
 - This has evidence of some repair work which may not be complete
- The bottom exit has 2 gates although one is currently missing and waiting repair.
- There is small signage adjacent to both entrances referring to visitors walking their dogs.

- Complete repair on Church end gate so this latches correctly.
- Complete repair on bottom gates reinstating the missing gate and ensuring they close and latch correctly.
- Cut back bramble on hedges adjacent to the gates
- Improve signage for dog walker
- Consider signage for general visitors on good practice within the grounds

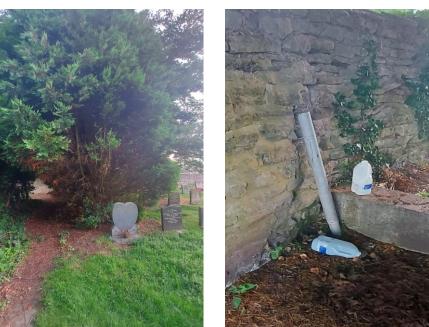
D – Water Standpipe

- A water standpipe is located near to the recreation ground no indication or markings to identify who's responsibility this item is.
- Access route to this item is through a non-designated route with low hanging branches on a tree.

Monitoring of the standpipe for damage to the lagging or pipework should be put in place to prevent leaking and wastage of water.

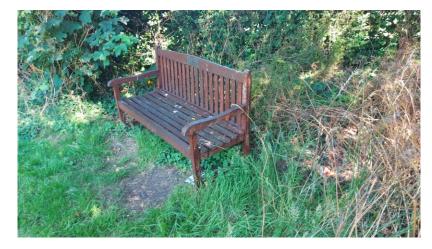
E – Memorial Bench

• A memorial bench is located in one corner of the burial ground

- Clear high foliage around the bench to make the area look more attractive.
- Remove litter accumulated behind the bench and in the bushes.

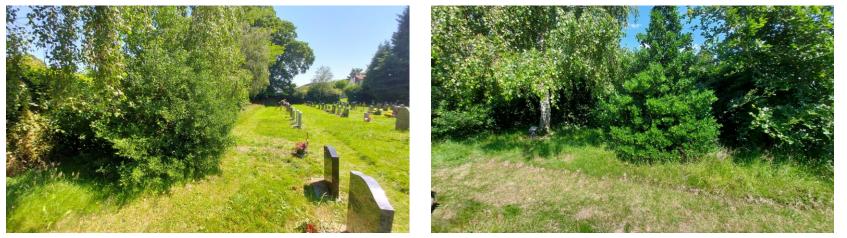
F – Holly Bushes

- There are two holly bushes alongside the recreation ground side of the burial ground.
- One of these impedes onto the route past several memorials

• Cut back and maintain the bushes to allow safe access and egress in this area

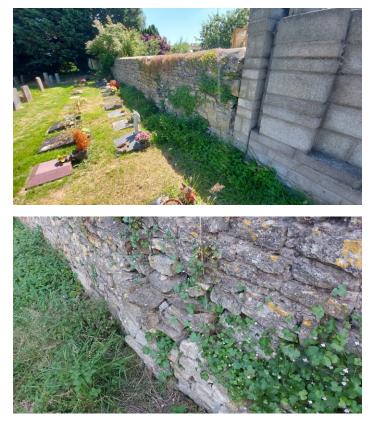
G – Old Stone Wall

- The wall alongside the burial ground is made up of breeze block and original old stone walling
- There is damage to one section of the old wall which has potential to fall onto the cremation plaques

Determine who the wall belongs to so the damage can be assessed and repaired. H & I – Memorials
