Pucklechurch Parish Burial Ground

Area Assessment and Headstone report – September 2024

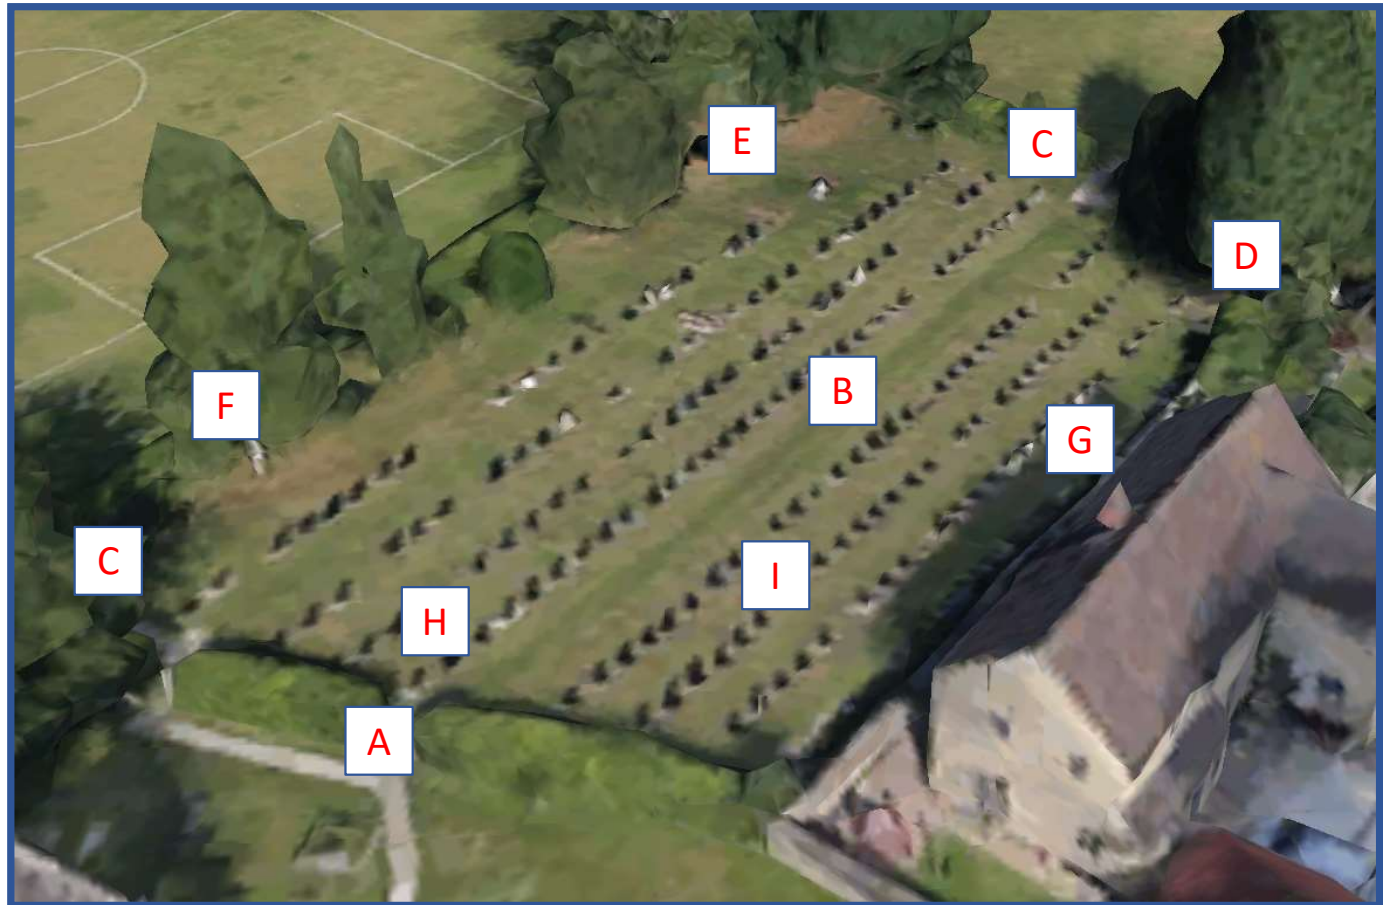
Pucklechurch Burial Ground - Overview

General Info.	Hazards
A – Entrance from Churchyard	None
B – Main walkway / footpaths	Uneven surface in some area
C – Exits onto Recreation ground	Gates not closed
D – Water standpipe	Frost protection / Leak control
E – Memorial Bench	None
F – Holly Bushes	None
G – Old stone wall	Damage in one area
H – Headstone	No headstones failed the “wobble test”
I – Other headstones	Passed “wobble test” although leaning

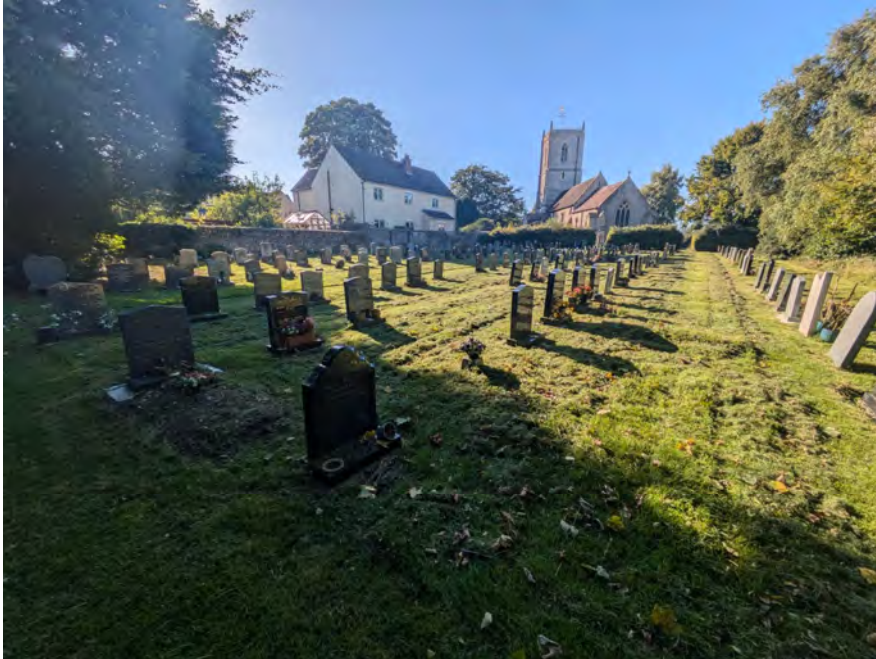
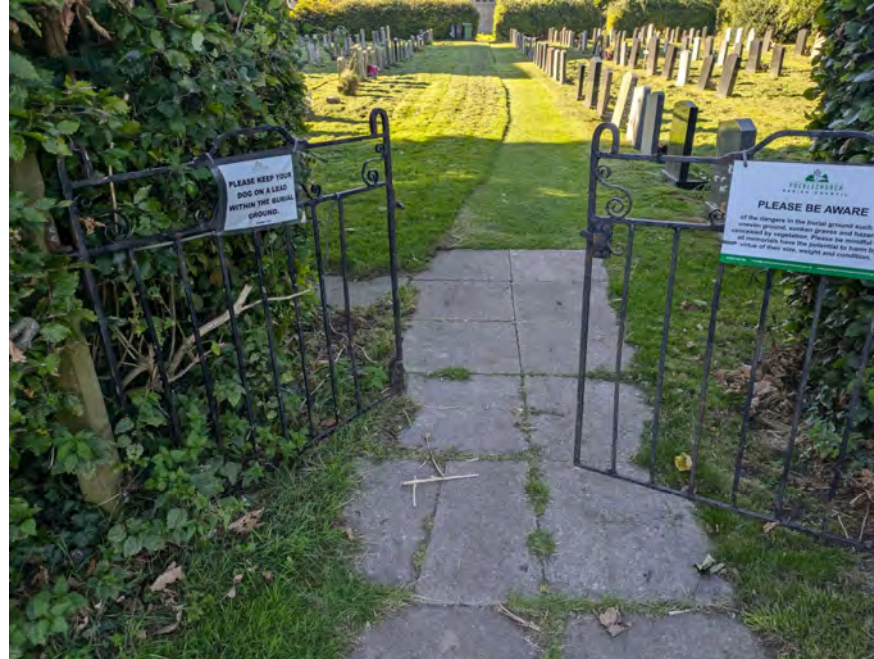
A – Entrance from Churchyard & C – Entrance from Recreation Ground

- The entrance from the churchyard consists of an access route with no gate but high bushes on either side are under control and evidence of cutting back was seen
- The entrance from the recreation ground is through a pair of gates. These gates have signage for dog walkers plus a “please be aware” sign making visitors aware of hazards likely to be in the burial ground
- Signage for dog walkers is hidden when walking in certain directions or if the gates are left open.

- Replace dog sign with improved sign (larger) and to include “please close the gates”

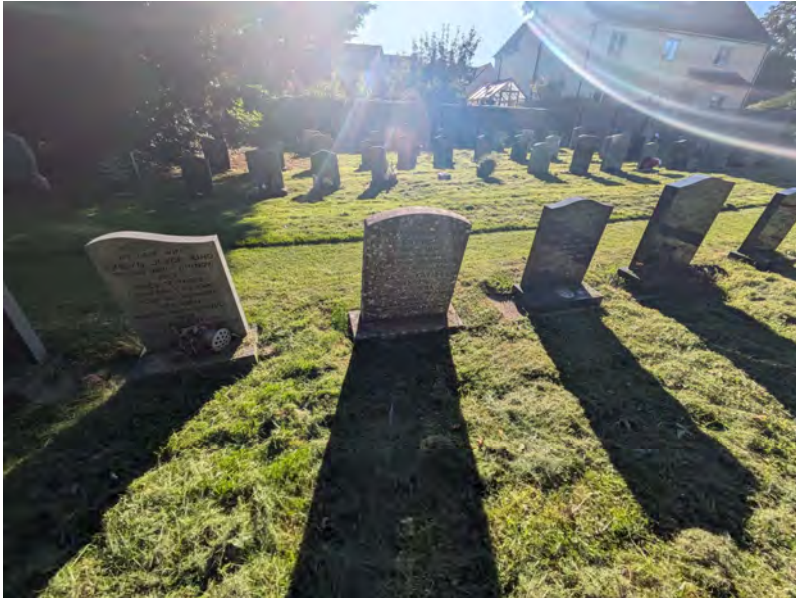
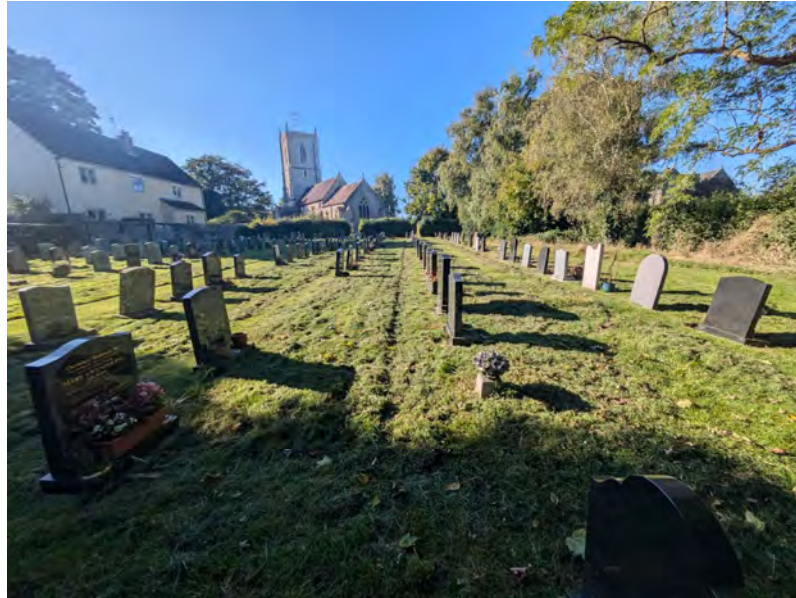
B – Main footpaths and Access Routes

- The routes are made up of cut grassed pathways which had been recently cut clearly identifying the major route through the burial ground.
- Some of the routes are still uneven and difficult to identify any hazard within the surface
- Grass cuttings were not removed in areas around graves. Some of these had new flowers and the grass cuttings had potential to damage but also upset the families who had placed them.

- Ask landscape contractor to continue identifying any areas which are potential trip / fall hazards and to make safe.
- Maintain program of grass cutting to reduce risk
- Ask landscape contractor to remove grass cuttings which are on gravestones (leaf blower).

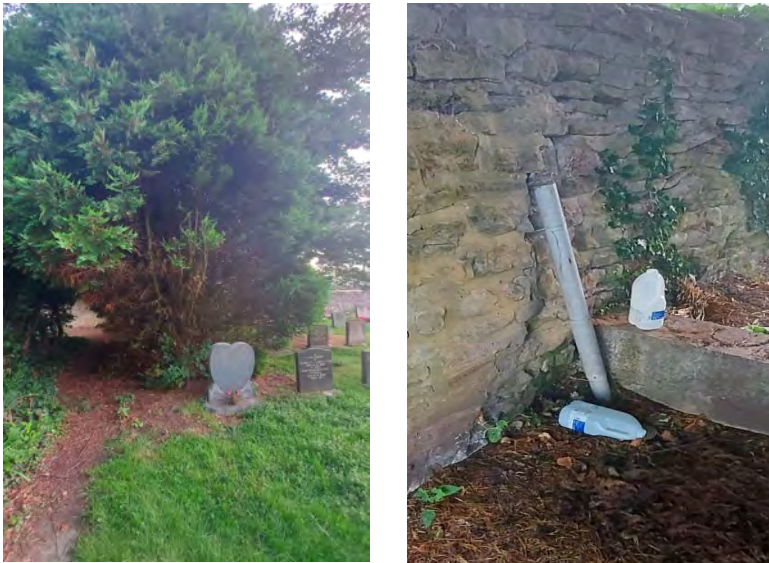
D – Water Standpipe

- A water standpipe is located near to the recreation ground – no indication or markings to identify who's responsibility this item is.
- Access route to this item is through a non-designated route with low hanging branches on a tree.
- Various empty cans (alcohol & soft drinks) were discarded in this area. Area cleared by myself on this occasion.

- Continued monitoring of the standpipe for damage to the lagging or pipework should be put in place to prevent leaking and wastage of water.

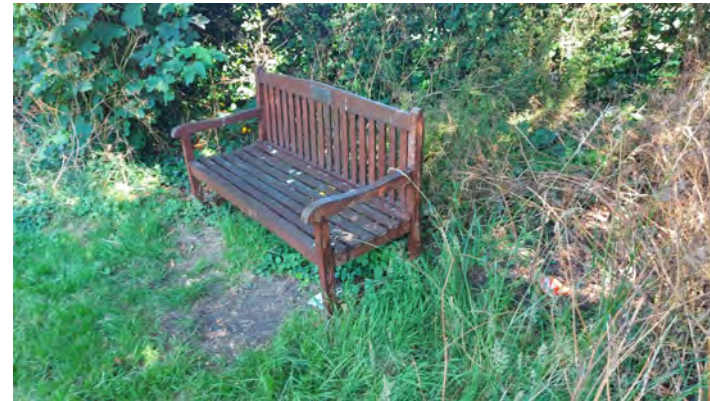
E – Memorial Bench

- A memorial bench is located in one corner of the burial ground
- The area around this has been cleared and left tidy (old image above).

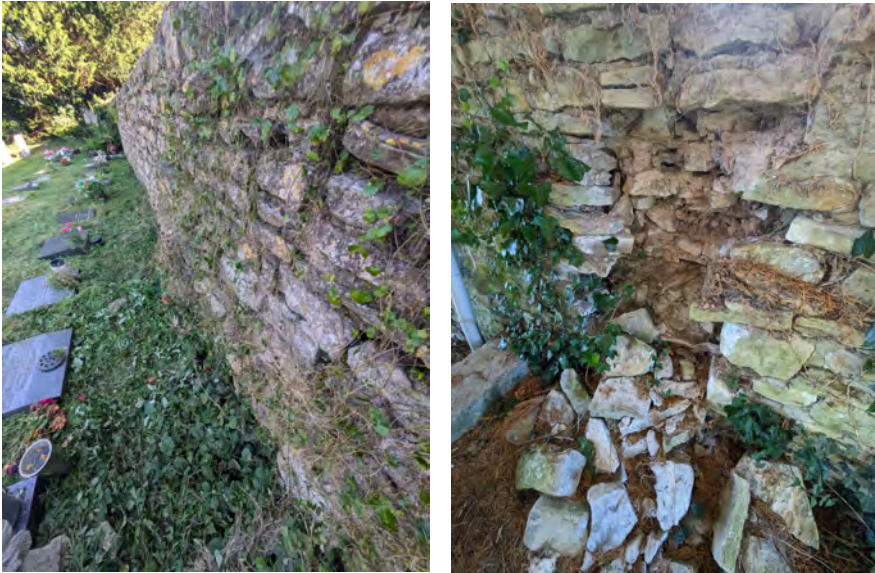
G – Old Stone Wall

- The wall alongside the burial ground is made up of breeze block and original old stone walling
- There is damage to a section of the old wall which has potential to fall onto the cremation plaques

- Repair wall to make safe

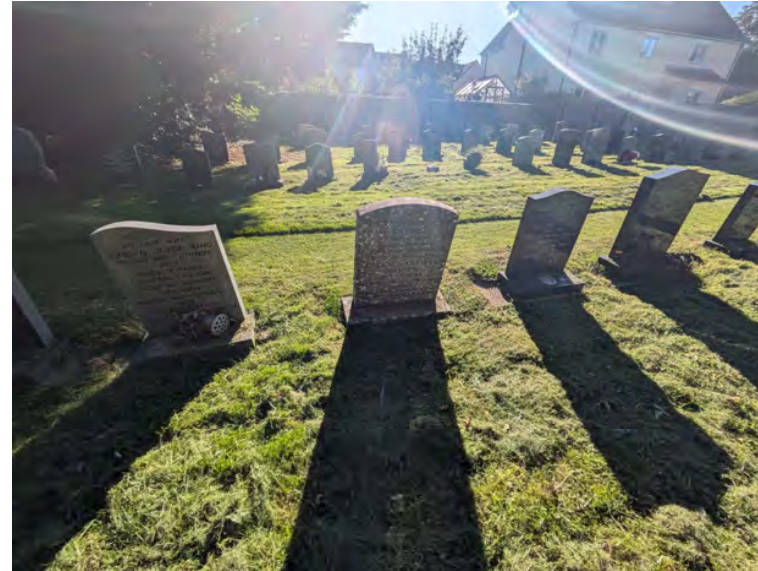
H & I – Headstones

- Every headstone passed the “wobble test”, previous failures have been repaired.
- Several headstones are leaning although they do not wobble under any pressure and are deemed to be safe
- Some areas of ground in front of the headstones are uneven.

- Visual monitoring of gravestones for movement during inspections and by landscape contractor.
