# **GORDON PLAYGROUND INSPECTIONS LTD**

**Inspected by:** Louisa Hill

## **Annual Inspection 2020 Pucklechurch Parish Council**

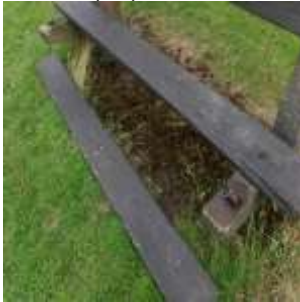
Asset Name	Finding Title	Finding Creation	Resolve By Date	Risk Level	Risk Value	Standard Ref	Cause
Bench Seat	Fixtures - Loose or Missing	08/07/2020	08/08/2020	Low	2 x 3 = 6		Wear and Tear

**Standard Description:** Fixtures loose or missing

Replace missing fasteners, fixtures and fitting

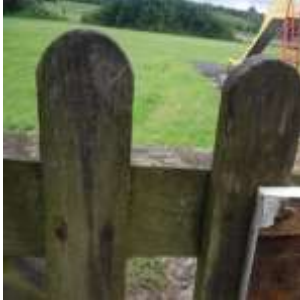
Asset Name	Finding Title	Finding Creation	Resolve By Date	Risk Level	Risk Value	Standard Ref	Cause
Gate Pedestrian	Entrapment - Head & Neck	08/07/2020	08/07/2021	Very Low	$1 \times 3 = 3$	EN 1176:2017 - 1 - 4.2.7.2	Manufacturer Defect

No action given the risk assessment

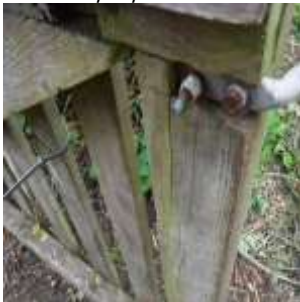
Asset Name	Finding Title	Finding Creation	Resolve By Date	Risk Level	Risk Value	Standard Ref	Cause
Gate Pedestrian	Finish - Bolts Protruding	08/07/2020	08/10/2020	Low	$2 \times 2 = 4$	EN 1176:2017 - 1 - 4.2.5	Installation Defect

Remove excessive threads

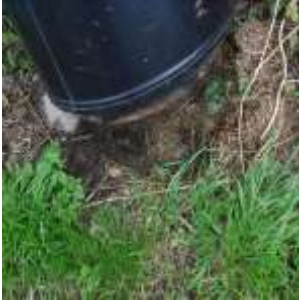
Asset Name	Finding Title	Finding Creation	Resolve By Date	Risk Level	Risk Value	Standard Ref	Cause
Litter Bin	Item - Loose in Ground	08/07/2020	07/01/2021	Very Low	1 x 2 = 2		Installation Defect

**Standard Description:** Loose in ground

Secure fixing devices

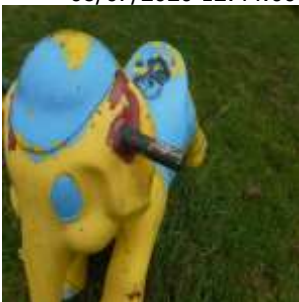
Asset Name	Finding Title	Finding Creation	Resolve By Date	Risk Level	Risk Value	Standard Ref	Cause
Rocker Elephant	Foot Rests - Shape	08/07/2020	08/07/2021	Very Low	1 x 3 = 3	EN 1176:2017 - 6 - 4.6	Manufacturer Defect

No action required, based on risk assessment, as asset pre-dates EN 1176

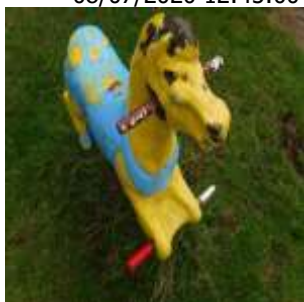
Asset Name	Finding Title	Finding Creation	Resolve By Date	Risk Level	Risk Value	Standard Ref	Cause
Rocker Horse	Hand Supports and Foot Rests - Shape	08/07/2020	08/07/2021	Very Low	1 x 3 = 3	EN 1176:2017 - 6 - 4.6 and 4.7	Manufacturer Defect

No action required, based on risk assessment, as asset pre-dates EN 1176

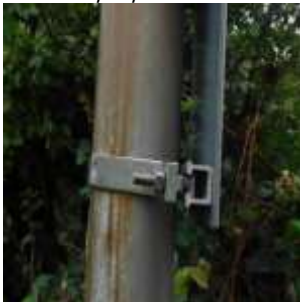
Asset Name	Finding Title	Finding Creation	Resolve By Date	Risk Level	Risk Value	Standard Ref	Cause
Signage	Finish - Bolts Protruding	08/07/2020	07/01/2021	Very Low	1 x 2 = 2	EN 1176:2017 - 1 - 4.2.5	Installation Defect

Remove excessive threads

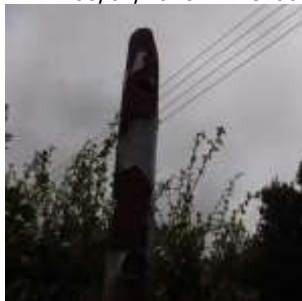
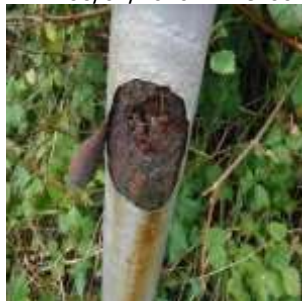
Asset Name	Finding Title	Finding Creation	Resolve By Date	Risk Level	Risk Value	Standard Ref	Cause
Signage	Item - Rusting in places	08/07/2020	08/07/2021	Very Low	1 x 2 = 2		Wear and Tear

**Standard Description:** Item is rusting in places

Monitor

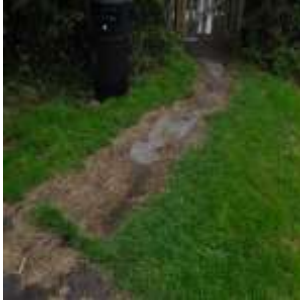
Asset Name	Finding Title	Finding Creation	Resolve By Date	Risk Level	Risk Value	Standard Ref	Cause
Site - Shortwood	Surface - Weeds	08/07/2020	07/01/2021	Very Low	1 x 2 = 2		Routine

Remove weeds

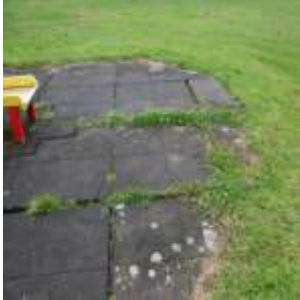
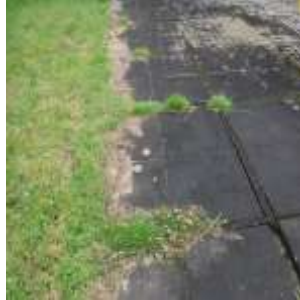
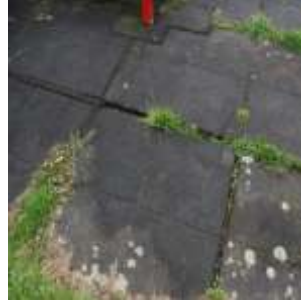
Asset Name	Finding Title	Finding Creation	Resolve By Date	Risk Level	Risk Value	Standard Ref	Cause
Slide Free Standing - Surface	Surface - Tiles - Gaps	08/07/2020	07/01/2021	Very Low	$1 \times 3 = 3$		Wear and Tear

Close / fill gaps

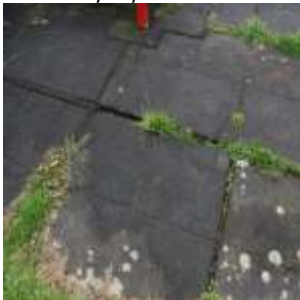
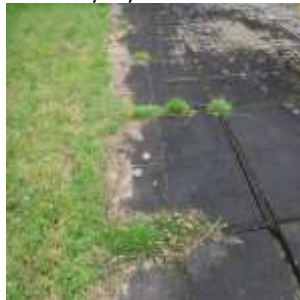
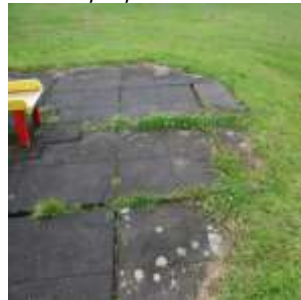
Asset Name	Finding Title	Finding Creation	Resolve By Date	Risk Level	Risk Value	Standard Ref	Cause
Slide Free Standing - Surface	Surface - Weeds	08/07/2020	07/01/2021	Very Low	$1 \times 2 = 2$		Routine

Remove weeds

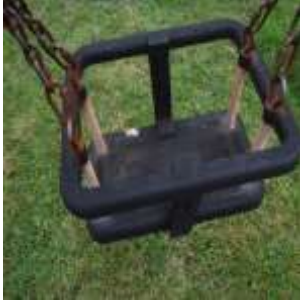
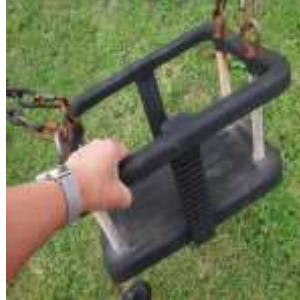
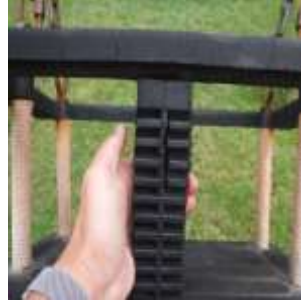
Asset Name	Finding Title	Finding Creation	Resolve By Date	Risk Level	Risk Value	Standard Ref	Cause
Swing - 1 Bay Cradle Seats	Swing - Seat - Degrading	08/07/2020	07/01/2021	Very Low	1 x 2 = 2		Wear and Tear

**Standard Description:** The rubber is deteriorating/degrading

Replace item

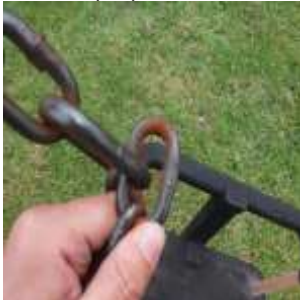
Asset Name	Finding Title	Finding Creation	Resolve By Date	Risk Level	Risk Value	Standard Ref	Cause
Swing - 1 Bay Cradle Seats	Chain - Links Worn	08/07/2020	08/07/2021	Very Low	1 x 3 = 3		Wear and Tear

**Standard Description:** Chains links worn

Monitor

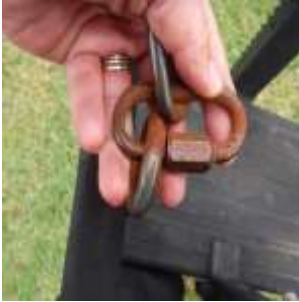
Asset Name	Finding Title	Finding Creation	Resolve By Date	Risk Level	Risk Value	Standard Ref	Cause
Swing - 1 Bay Cradle Seats	Chain - Connectors Worn	08/07/2020	08/07/2021	Very Low	1 x 3 = 3		Wear and Tear

**Standard Description:** Chain link connectors worn

Monitor

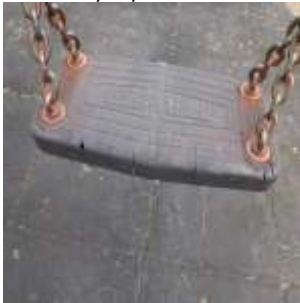
Asset Name	Finding Title	Finding Creation	Resolve By Date	Risk Level	Risk Value	Standard Ref	Cause
Swing - 1 Bay Flat Seats	Swing - Seat - Degrading	08/07/2020	07/01/2021	Very Low	1 x 2 = 2		Wear and Tear

**Standard Description:** The rubber is deteriorating/degrading

Replace item

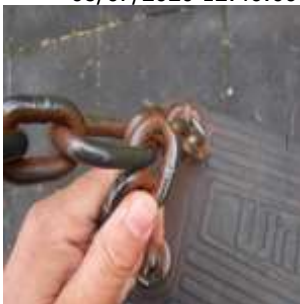
Asset Name	Finding Title	Finding Creation	Resolve By Date	Risk Level	Risk Value	Standard Ref	Cause
Swing - 1 Bay Flat Seats	Chain - Links Worn	08/07/2020	08/07/2021	Very Low	1 x 3 = 3		Wear and Tear

**Standard Description:** Chains links worn

Monitor

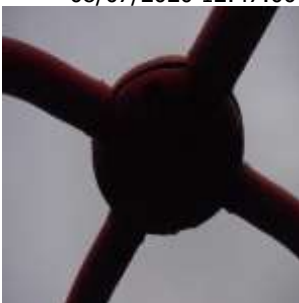
Asset Name	Finding Title	Finding Creation	Resolve By Date	Risk Level	Risk Value	Standard Ref	Cause
Swing - 1 Bay Flat Seats	Fixtures - Loose or Missing	08/07/2020	08/10/2020	Low	2 x 4 = 8		Wear and Tear

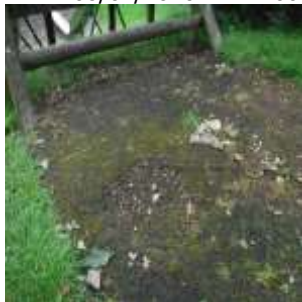
Asset Name	Finding Title	Finding Creation	Resolve By Date	Risk Level	Risk Value	Standard Ref	Cause
Multiplay Unit Junior - Surface	Surface - Needs Repair	08/07/2020	07/01/2021	Very Low	$1 \times 3 = 3$		Wear and Tear

**Standard Description:** Surface needs repair

Repair surface

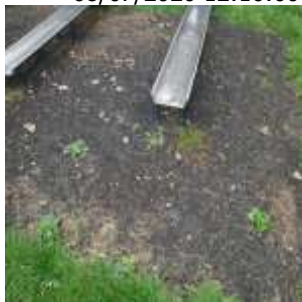
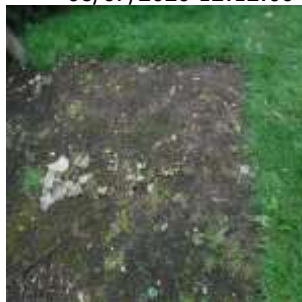
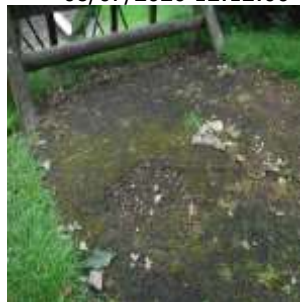
Asset Name	Finding Title	Finding Creation	Resolve By Date	Risk Level	Risk Value	Standard Ref	Cause
Multiplay Unit Junior - Surface	Surface - Weeds	08/07/2020	07/01/2021	Very Low	$1 \times 2 = 2$		Routine

Remove weeds

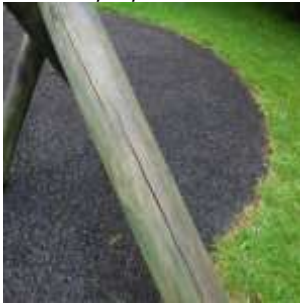
Asset Name	Finding Title	Finding Creation	Resolve By Date	Risk Level	Risk Value	Standard Ref	Cause
Swing - Single Point	Timber - New Wide Cracks	08/07/2020	08/07/2021	Very Low	1 x 1 = 1		Wear and Tear

**Standard Description:** Timber new wide cracks

Monitor

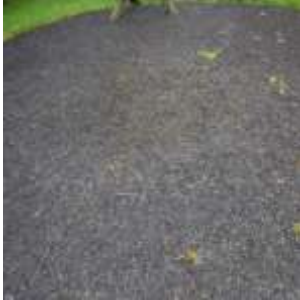
Asset Name	Finding Title	Finding Creation	Resolve By Date	Risk Level	Risk Value	Standard Ref	Cause
Swing - Single Point - Surface	Surface - Wearing	08/07/2020	08/07/2021	Very Low	1 x 2 = 2		Wear and Tear

**Standard Description:** Surface wearing

Monitor

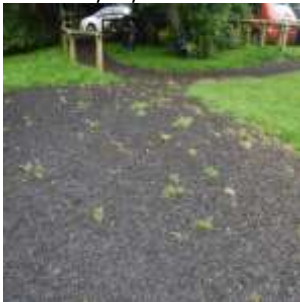
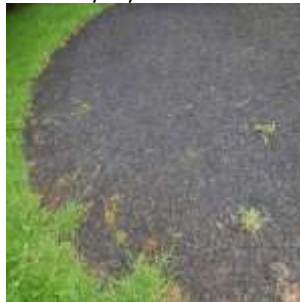
Asset Name	Finding Title	Finding Creation	Resolve By Date	Risk Level	Risk Value	Standard Ref	Cause
Swing - Single Point - Surface	Surface - Weeds	08/07/2020	07/01/2021	Very Low	1 x 2 = 2		Routine

Remove weeds

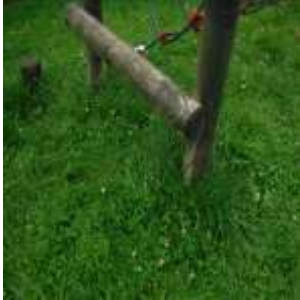
Asset Name	Finding Title	Finding Creation	Resolve By Date	Risk Level	Risk Value	Standard Ref	Cause
Trim Trail	Item - Loose in Ground	08/07/2020	08/07/2021	Very Low	1 x 3 = 3		Wear and Tear

**Standard Description:** Loose in ground

Monitor

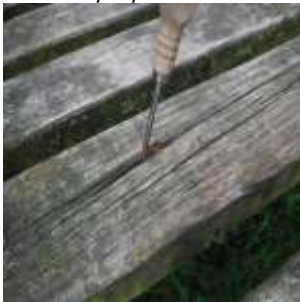
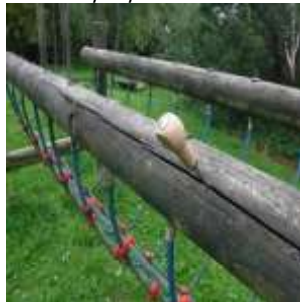
Asset Name	Finding Title	Finding Creation	Resolve By Date	Risk Level	Risk Value	Standard Ref	Cause
Trim Trail	Timber - Not in Good Condition	08/07/2020	08/07/2021	Very Low	1 x 1 = 1		Wear and Tear

**Standard Description:** Timber condition

Monitor

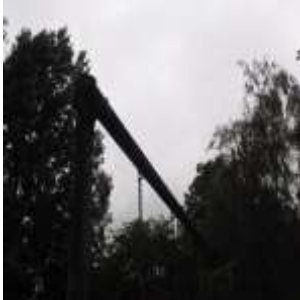
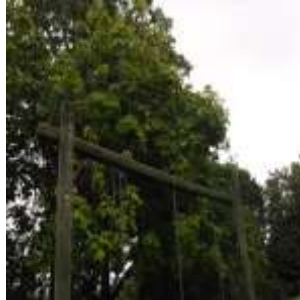
Asset Name	Finding Title	Finding Creation	Resolve By Date	Risk Level	Risk Value	Standard Ref	Cause
Trim Trail	RECOMMENDATIONS	08/07/2020	08/10/2020	Very Low	1 x 1 = 1		Wear and Tear

**Standard Description:** RECOMMENDATIONS

RECOMMENDATION

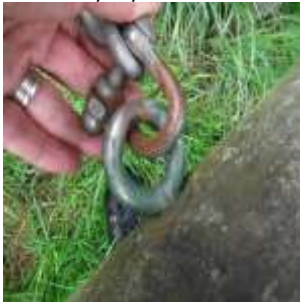
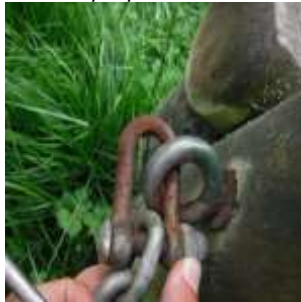
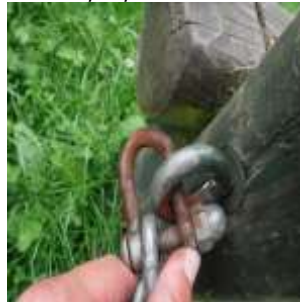
Asset Name	Finding Title	Finding Creation	Resolve By Date	Risk Level	Risk Value	Standard Ref	Cause
Trim Trail	Chain - Connectors Worn	08/07/2020	08/07/2021	Very Low	1 x 3 = 3		Wear and Tear

**Standard Description:** Chain link connectors worn

Monitor

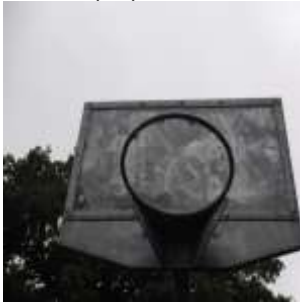
Asset Name	Finding Title	Finding Creation	Resolve By Date	Risk Level	Risk Value	Standard Ref	Cause
Basketball Post	Item - Damaged	08/07/2020	08/07/2021	Very Low	1 x 1 = 1		Wear and Tear

**Standard Description:** Item is damaged

Replace item

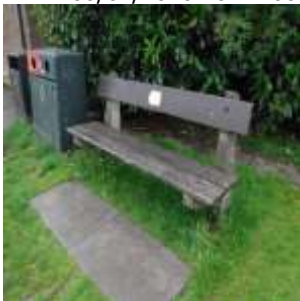
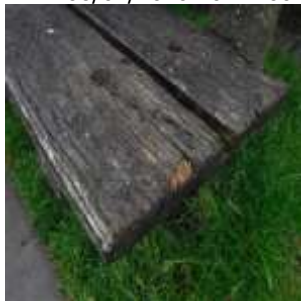
**Standard Description:** Timber condition

Monitor

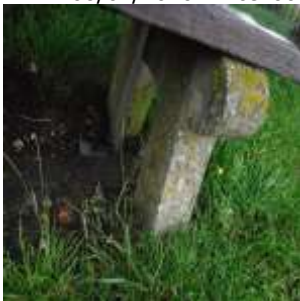
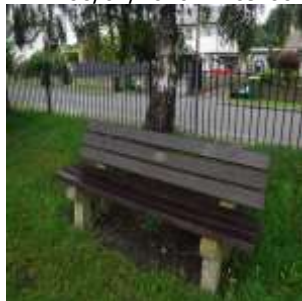
**Standard Description:** Loose in ground

Secure fixing devices

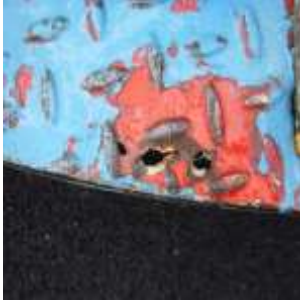
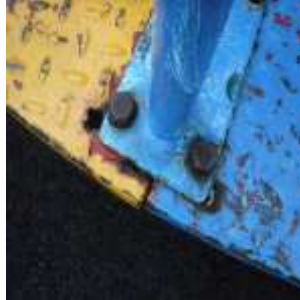
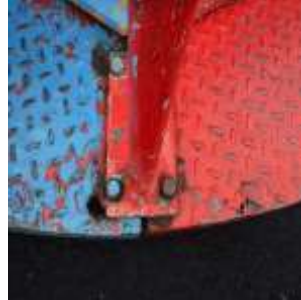
Asset Name	Finding Title	Finding Creation	Resolve By Date	Risk Level	Risk Value	Standard Ref	Cause
Carousel	Metal - Excessive Corrosion	08/07/2020	08/10/2020	Low	$2 \times 4 = 8$		Wear and Tear

**Standard Description:** Metal excessive corrosion

Repair item

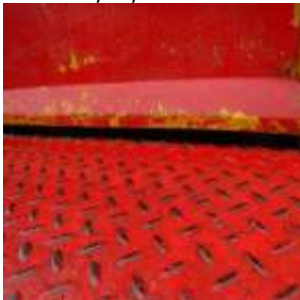
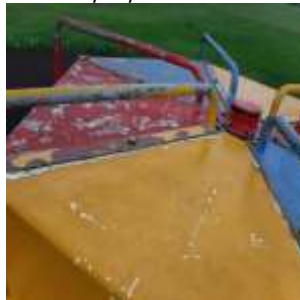
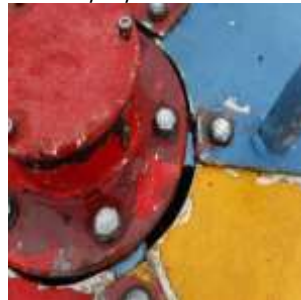
Asset Name	Finding Title	Finding Creation	Resolve By Date	Risk Level	Risk Value	Standard Ref	Cause
Carousel	EN1176 - Part 1 and Part 5 - Compliance	08/07/2020	08/07/2021	Very Low	$1 \times 3 = 3$	EN 1176:2017 - 1 and EN1176:2019 - 5	Manufacturer Defect

No action required, based on risk assessment, as asset pre-dates EN 1176

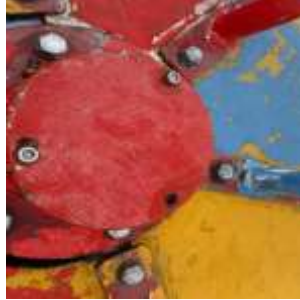
Asset Name	Finding Title	Finding Creation	Resolve By Date	Risk Level	Risk Value	Standard Ref	Cause
Carousel	Fixtures - Loose or Missing	08/07/2020	07/01/2021	Very Low	1 x 2 = 2		Wear and Tear

**Standard Description:** Fixtures loose or missing

Replace missing fasteners, fixtures and fitting

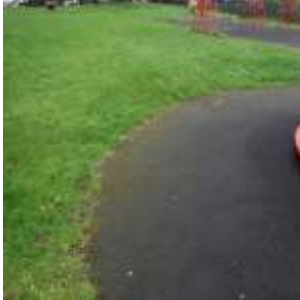
Asset Name	Finding Title	Finding Creation	Resolve By Date	Risk Level	Risk Value	Standard Ref	Cause
Carousel - Surface	Surface - Moss	08/07/2020	07/01/2021	Very Low	$1 \times 3 = 3$		Routine

Power Wash

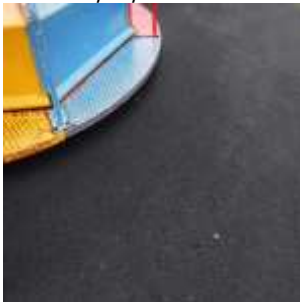
Asset Name	Finding Title	Finding Creation	Resolve By Date	Risk Level	Risk Value	Standard Ref	Cause
Carousel - Surface	Surface - Wearing	08/07/2020	24/07/2021	Very Low	$1 \times 2 = 2$		Wear and Tear

**Standard Description:** Surface wearing

Monitor

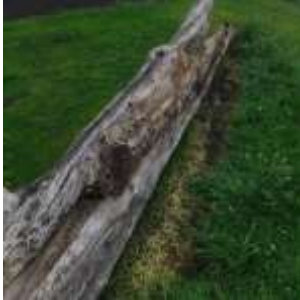
Asset Name	Finding Title	Finding Creation	Resolve By Date	Risk Level	Risk Value	Standard Ref	Cause
Fallen Tree Trunks	Item - Loose in Ground	08/07/2020	08/10/2020	Low	$2 \times 3 = 6$		Installation Defect

**Standard Description:** Loose in ground

Secure fixing devices

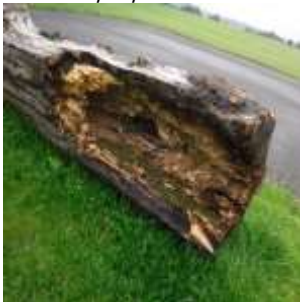
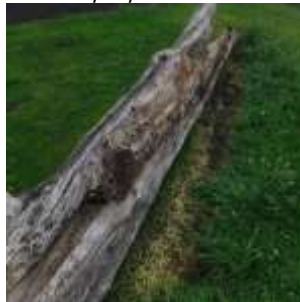
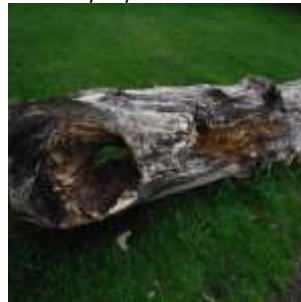
Asset Name	Finding Title	Finding Creation	Resolve By Date	Risk Level	Risk Value	Standard Ref	Cause
Fallen Tree Trunks	Timber - Rotting	08/07/2020	08/07/2021	Very Low	$1 \times 2 = 2$		Wear and Tear

Monitor

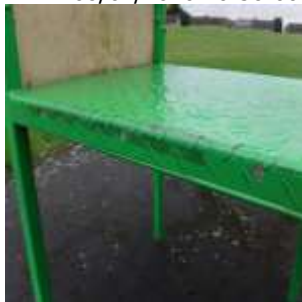
Asset Name	Finding Title	Finding Creation	Resolve By Date	Risk Level	Risk Value	Standard Ref	Cause
Multiplay Unit Toddler	Item - Cap(s) missing	08/07/2020	07/01/2021	Very Low	1 x 2 = 2		Wear and Tear

**Standard Description:** Cap(s) missing

Replace

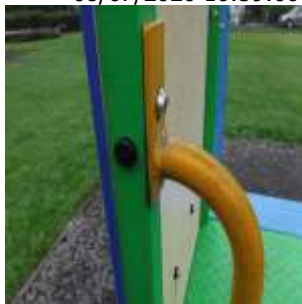
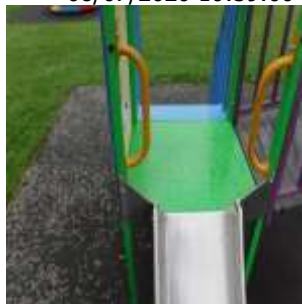
Asset Name	Finding Title	Finding Creation	Resolve By Date	Risk Level	Risk Value	Standard Ref	Cause
Multiplay Unit Toddler	Fixtures - Loose or Missing	08/07/2020	08/10/2020	Very Low	1 x 3 = 3		Wear and Tear

**Standard Description:** Fixtures loose or missing

Tighten loose fixtures & fittings

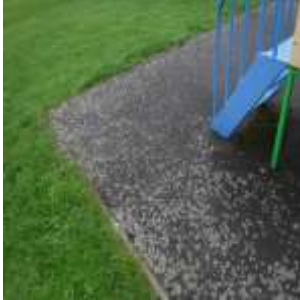
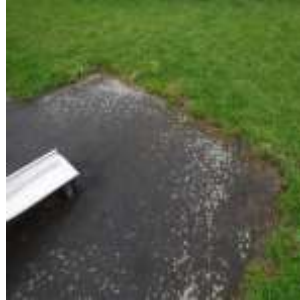
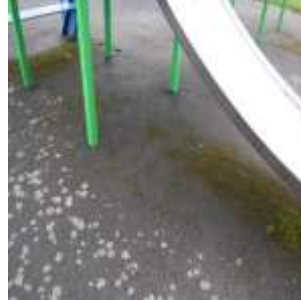
Asset Name	Finding Title	Finding Creation	Resolve By Date	Risk Level	Risk Value	Standard Ref	Cause
Multiplay Unit Toddler - Surface	Surface - Moss	08/07/2020	07/01/2021	Very Low	1 x 3 = 3		Routine

Power Wash

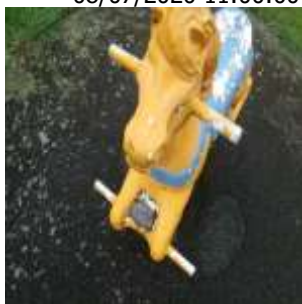
Asset Name	Finding Title	Finding Creation	Resolve By Date	Risk Level	Risk Value	Standard Ref	Cause
Rocker Horse	Hand Supports and Foot Rests - Shape	08/07/2020	08/07/2021	Very Low	1 x 3 = 3	EN 1176:2017 - 6 - 4.6 and 4.7	Manufacturer Defect

No action required, based on risk assessment, as asset pre-dates EN 1176

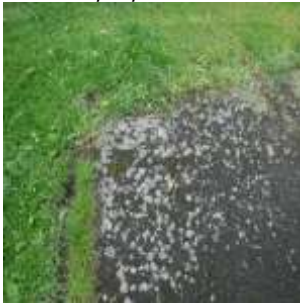
Asset Name	Finding Title	Finding Creation	Resolve By Date	Risk Level	Risk Value	Standard Ref	Cause
Rocker Horse - Surface	Surface - Moss	08/07/2020	07/01/2021	Very Low	1 x 3 = 3		Routine

Power Wash

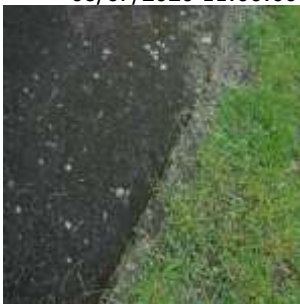
Asset Name	Finding Title	Finding Creation	Resolve By Date	Risk Level	Risk Value	Standard Ref	Cause
Rocker Horse - Surface	Surface - Edges Shrunk	08/07/2020	07/01/2021	Very Low	1 x 3 = 3		Wear and Tear

Repair edges

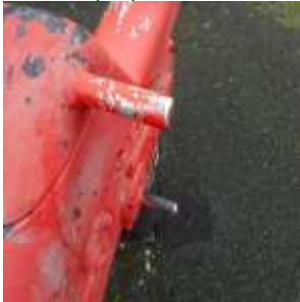
Asset Name	Finding Title	Finding Creation	Resolve By Date	Risk Level	Risk Value	Standard Ref	Cause
Rocker Motorbike	Hand Supports and Foot Rests - Shape	08/07/2020	08/07/2021	Very Low	1 x 3 = 3	EN 1176:2017 - 6 - 4.6 and 4.7	Manufacturer Defect

No action required, based on risk assessment, as asset pre-dates EN 1176

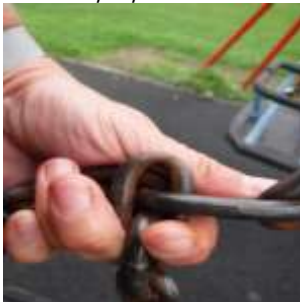
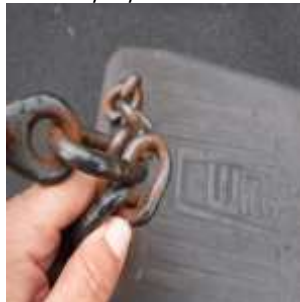
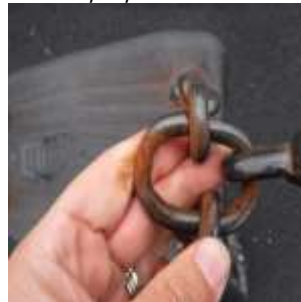
Asset Name	Finding Title	Finding Creation	Resolve By Date	Risk Level	Risk Value	Standard Ref	Cause
Swing - 2 Bay Mixed Seat	Chain - Links Worn	08/07/2020	08/07/2021	Very Low	$1 \times 3 = 3$		Wear and Tear

**Standard Description:** Chains links worn

Monitor

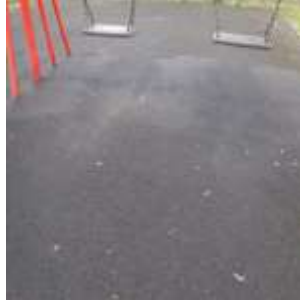
Asset Name	Finding Title	Finding Creation	Resolve By Date	Risk Level	Risk Value	Standard Ref	Cause
Swing - 2 Bay Mixed Seat - Surface	Surface - Wearing	08/07/2020	08/07/2021	Very Low	$1 \times 1 = 1$		Wear and Tear

**Standard Description:** Surface wearing

Monitor

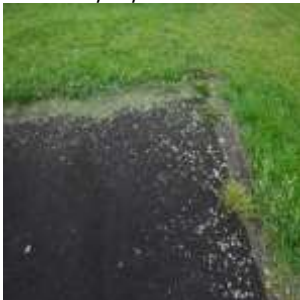
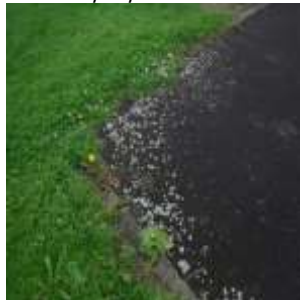
Asset Name	Finding Title	Finding Creation	Resolve By Date	Risk Level	Risk Value	Standard Ref	Cause
Swing - 2 Bay Mixed Seat - Surface	Surface - Moss	08/07/2020	07/01/2021	Very Low	$1 \times 3 = 3$		Routine

Power Wash

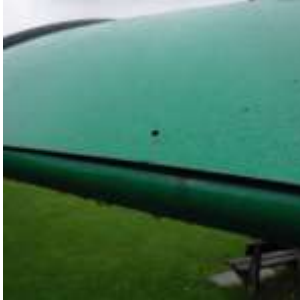
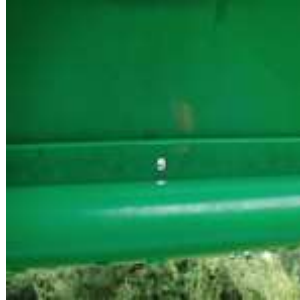
Asset Name	Finding Title	Finding Creation	Resolve By Date	Risk Level	Risk Value	Standard Ref	Cause
Teenage Shelter	Fixtures - Loose or Missing	08/07/2020	07/01/2021	Very Low	1 x 2 = 2		Wear and Tear

**Standard Description:** Fixtures loose or missing

Replace missing fasteners, fixtures and fitting

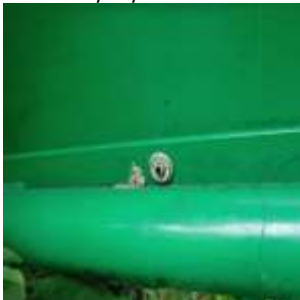
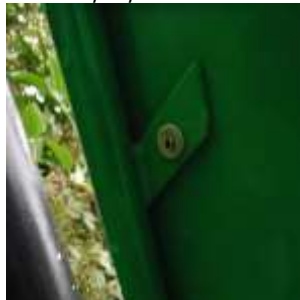
Asset Name	Finding Title	Finding Creation	Resolve By Date	Risk Level	Risk Value	Standard Ref	Cause
Teenage Shelter	Item - Cap(s) missing	08/07/2020	07/01/2021	Very Low	1 x 2 = 2		Wear and Tear

**Standard Description:** Cap(s) missing

Replace
