Gordon Playground  
Inspections LTD **PSSLive+**

## Annual Inspection 2023

**Pucklechurch Parish Council**

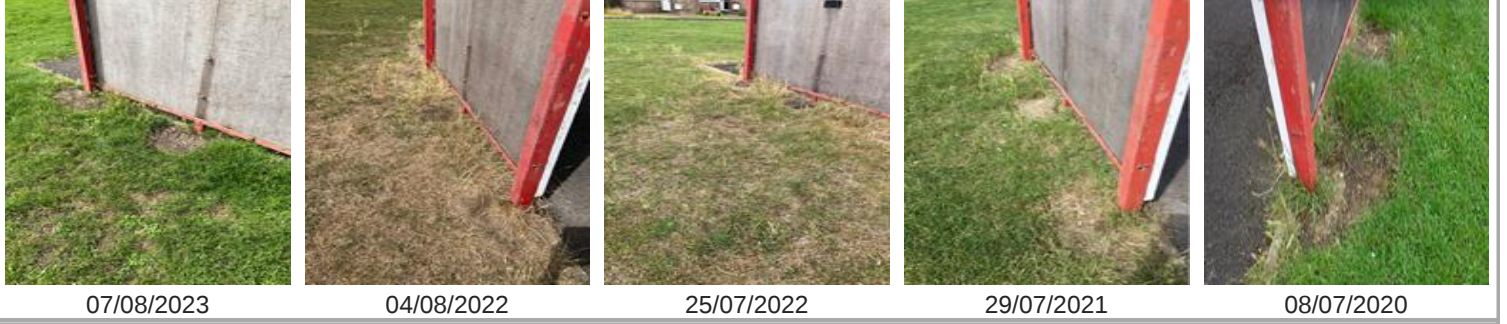
<b>Asset</b>	MUGA Single End - Surface
<b>Finding Group</b>	Maintenance
<b>Finding Title</b>	Ground Eroded
<b>Standard Reference</b>	
<b>Standard Description</b>	Ground eroded
<b>Finding Notes</b>	
<b>Cause</b>	Wear and Tear
<b>Finding Creation Date</b>	08/07/2020 12:45:00
<b>Risk Value Text</b>	1 x 2 = 2
<b>Risk Level</b>	Very Low
<b>Resolve By Date</b>	07/01/2021 12:45:00
<b>Finding Status</b>	Open

<b>Task Title</b>	Make good surface
<b>Task Notes</b>	
<b>Task Status</b>	Unapproved

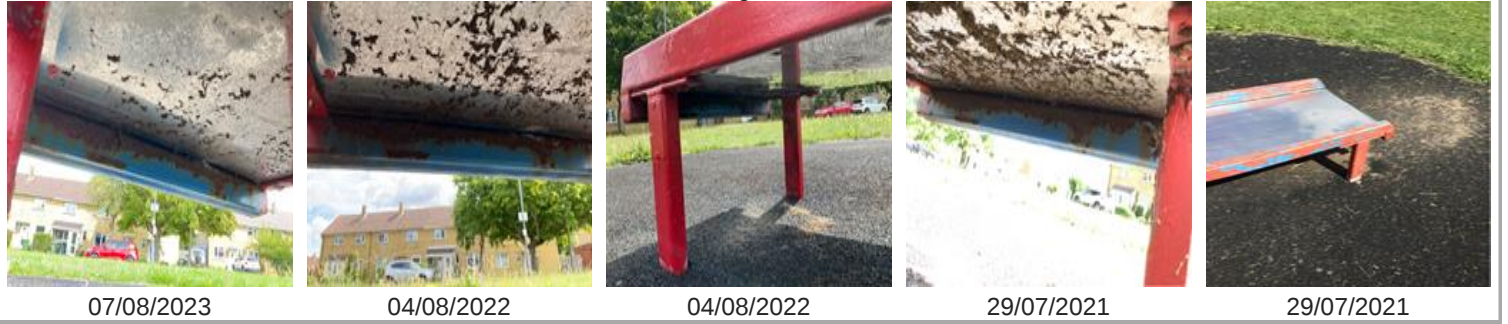
<p>Asset Photo</p>
<b>Finding Group</b>	Maintenance	
<b>Finding Title</b>	Item - Rusting in places	
<b>Standard Reference</b>		
<b>Standard Description</b>	Item is rusting in places	
<b>Finding Notes</b>	Under slide runout	
<b>Cause</b>	Wear and Tear	
<b>Finding Creation Date</b>	29/07/2021 11:19:01	
<b>Risk Value Text</b>	1 x 1 = 1	
<b>Risk Level</b>	Very Low	
<b>Resolve By Date</b>	13/01/2022 11:19:34	
<b>Finding Status</b>	Open

<b>Task Title</b>	De-rust and coat with paint meeting EN 1176 - 4.1.1 [1998]
<b>Task Notes</b>	
<b>Task Status</b>	Unapproved

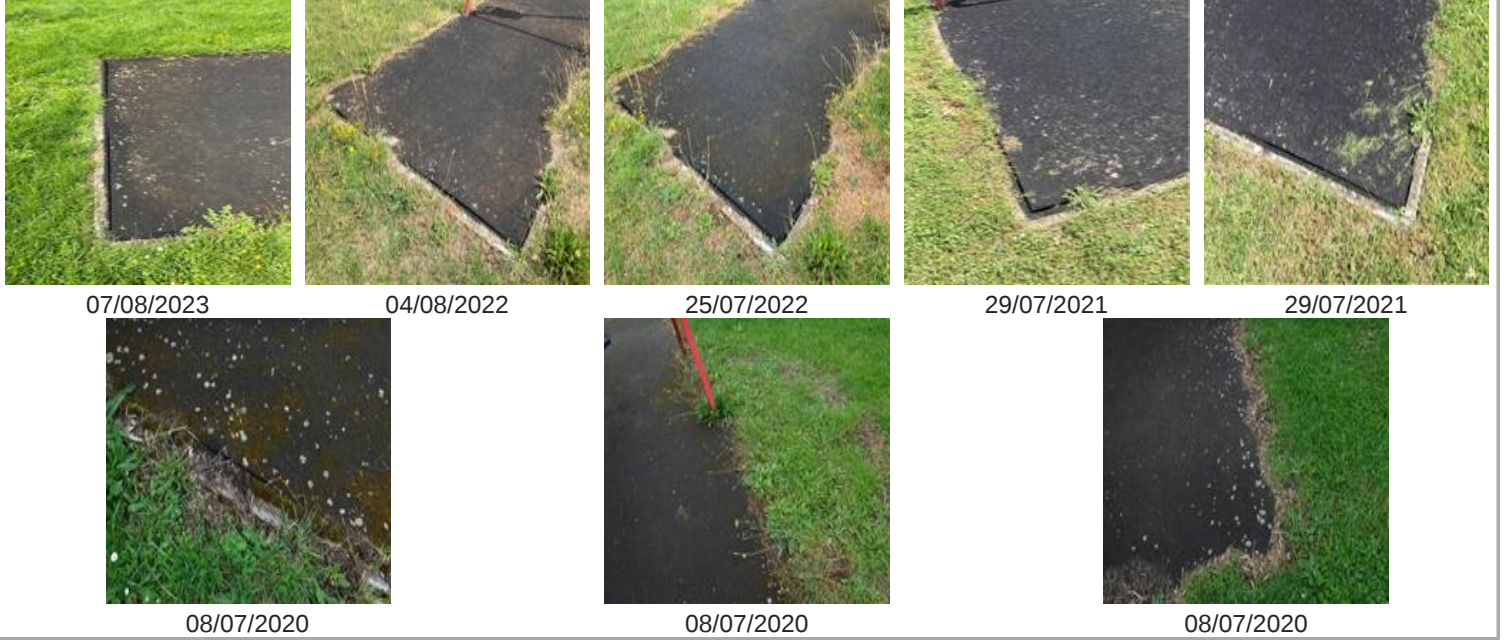
<b>Asset</b>	Swing - 1 Bay Cradle Seat - Surface
<b>Finding Group</b>	Maintenance
<b>Finding Title</b>	Surface - Edges Shrunk
<b>Standard Reference</b>	
<b>Standard Description</b>	Surface - Edges Shrunk
<b>Finding Notes</b>	
<b>Cause</b>	Wear and Tear
<b>Finding Creation Date</b>	08/07/2020 12:45:00
<b>Risk Value Text</b>	1 x 3 = 3
<b>Risk Level</b>	Very Low
<b>Resolve By Date</b>	07/01/2021 12:45:00
<b>Finding Status</b>	Open

<b>Task Title</b>	Repair edges
<b>Task Notes</b>	
<b>Task Status</b>	Unapproved

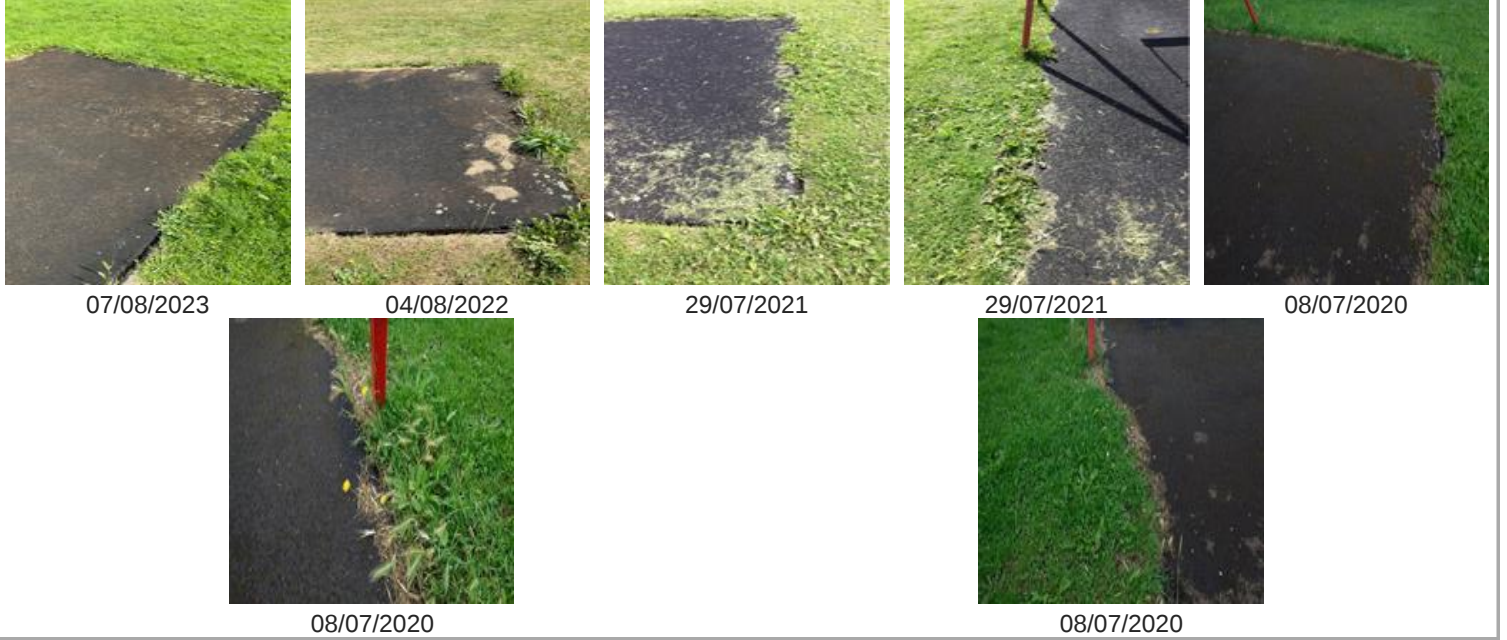
<b>Asset</b>	Swing - 1 Bay Flat Seat - Surface
<b>Finding Group</b>	Maintenance
<b>Finding Title</b>	Surface - Weeds
<b>Standard Reference</b>	
<b>Standard Description</b>	Surface has unintended weeds
<b>Finding Notes</b>	
<b>Cause</b>	Routine
<b>Finding Creation Date</b>	08/07/2020 12:45:00
<b>Risk Value Text</b>	1 x 2 = 2
<b>Risk Level</b>	Very Low
<b>Resolve By Date</b>	07/01/2021 12:45:00
<b>Finding Status</b>	Open

<b>Task Title</b>	Remove weeds
<b>Task Notes</b>	
<b>Task Status</b>	Unapproved

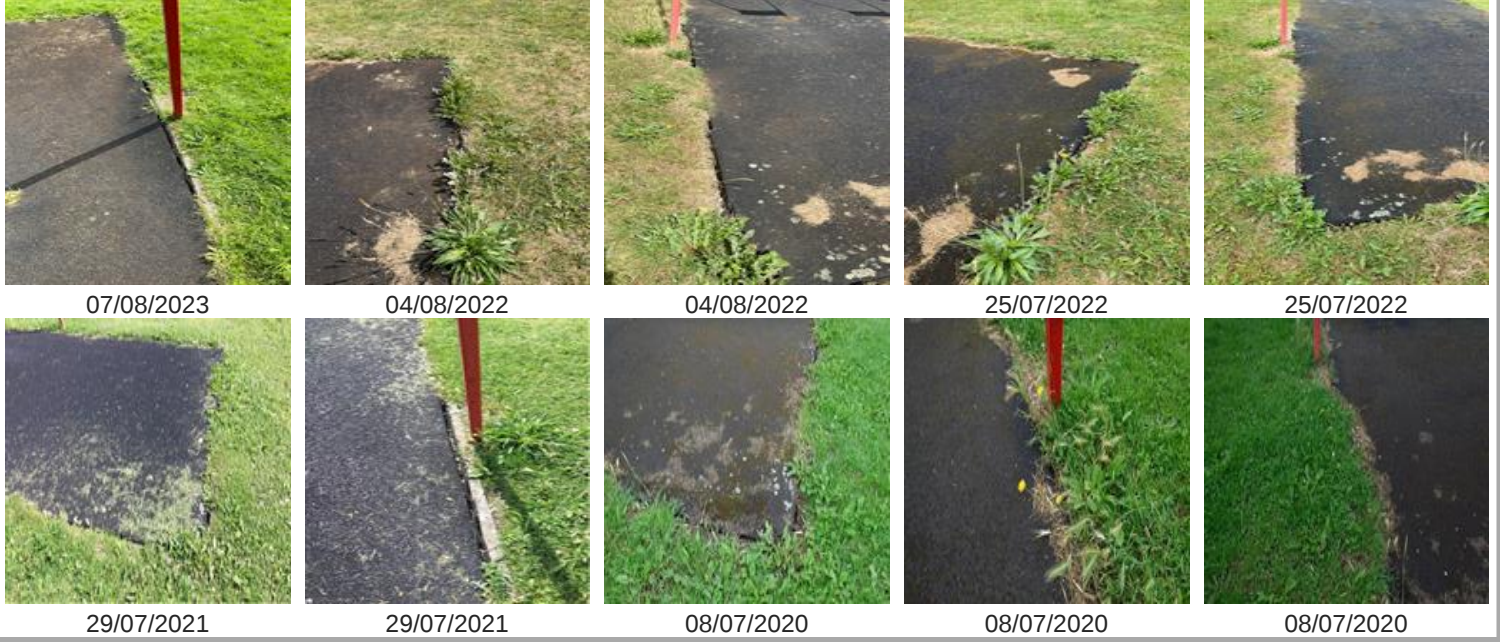
<b>Asset</b>	Swing - 1 Bay Flat Seat - Surface
<b>Finding Group</b>	Maintenance
<b>Finding Title</b>	Surface - Edges Shrunk
<b>Standard Reference</b>	
<b>Standard Description</b>	Surface - Edges Shrunk
<b>Finding Notes</b>	25.07.22 Condition deteriorated
<b>Cause</b>	Wear and Tear
<b>Finding Creation Date</b>	08/07/2020 12:45:00
<b>Risk Value Text</b>	2 x 3 = 6
<b>Risk Level</b>	Low
<b>Resolve By Date</b>	07/01/2021 12:45:00
<b>Finding Status</b>	Open

<b>Task Title</b>	Repair edges
<b>Task Notes</b>	
<b>Task Status</b>	Unapproved

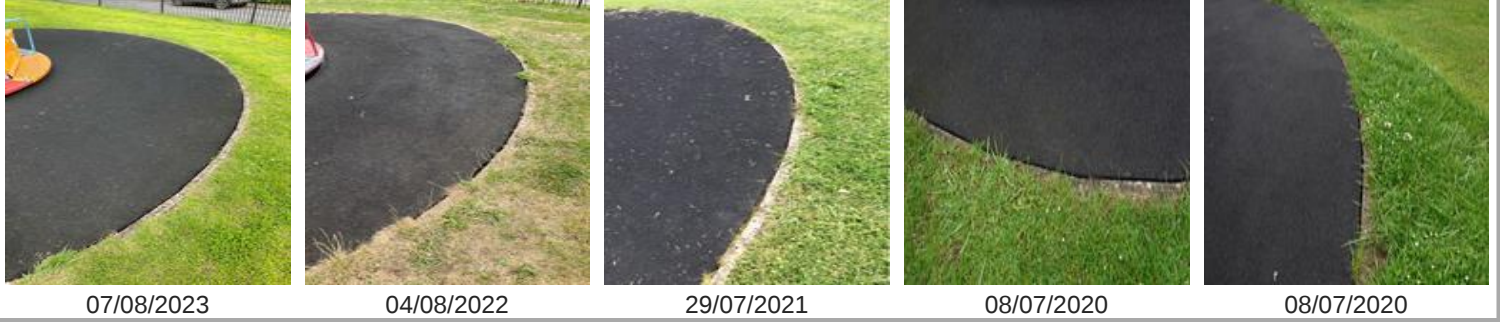
<b>Asset</b>	Carousel - Surface
<b>Finding Group</b>	Maintenance
<b>Finding Title</b>	Surface - Edges Shrunk
<b>Standard Reference</b>	
<b>Standard Description</b>	Surface - Edges Shrunk
<b>Finding Notes</b>	25.07.22 Condition deteriorated
<b>Cause</b>	Wear and Tear
<b>Finding Creation Date</b>	08/07/2020 12:13:00
<b>Risk Value Text</b>	2 x 3 = 6
<b>Risk Level</b>	Low
<b>Resolve By Date</b>	07/01/2021 12:13:00
<b>Finding Status</b>	Open

<b>Task Title</b>	Repair edges
<b>Task Notes</b>	
<b>Task Status</b>	Unapproved

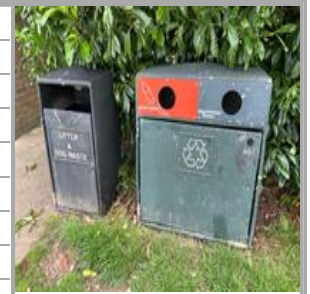
Asset	Litter Bins
Finding Group	Maintenance
Finding Title	Bin - Not locked
Standard Reference	
Standard Description	
Finding Notes	
Cause	Poor Maintenance
Finding Creation Date	08/07/2020 12:13:00
Risk Value Text	1 x 2 = 2
Risk Level	Very Low
Resolve By Date	22/07/2020 12:13:00
Finding Status	Open

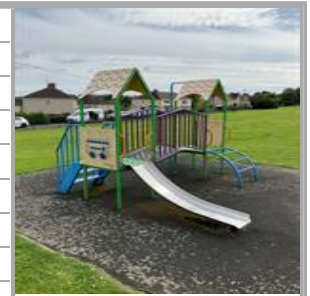
<b>Asset</b>	Multiplay Unit Toddler
<b>Finding Group</b>	Maintenance
<b>Finding Title</b>	Item - Parts Missing
<b>Standard Reference</b>	
<b>Standard Description</b>	Item has some parts missing
<b>Finding Notes</b>	
<b>Cause</b>	Wear and Tear
<b>Finding Creation Date</b>	29/07/2021 11:51:41
<b>Risk Value Text</b>	1 x 1 = 1
<b>Risk Level</b>	Very Low
<b>Resolve By Date</b>	13/01/2022 11:51:58
<b>Finding Status</b>	Open

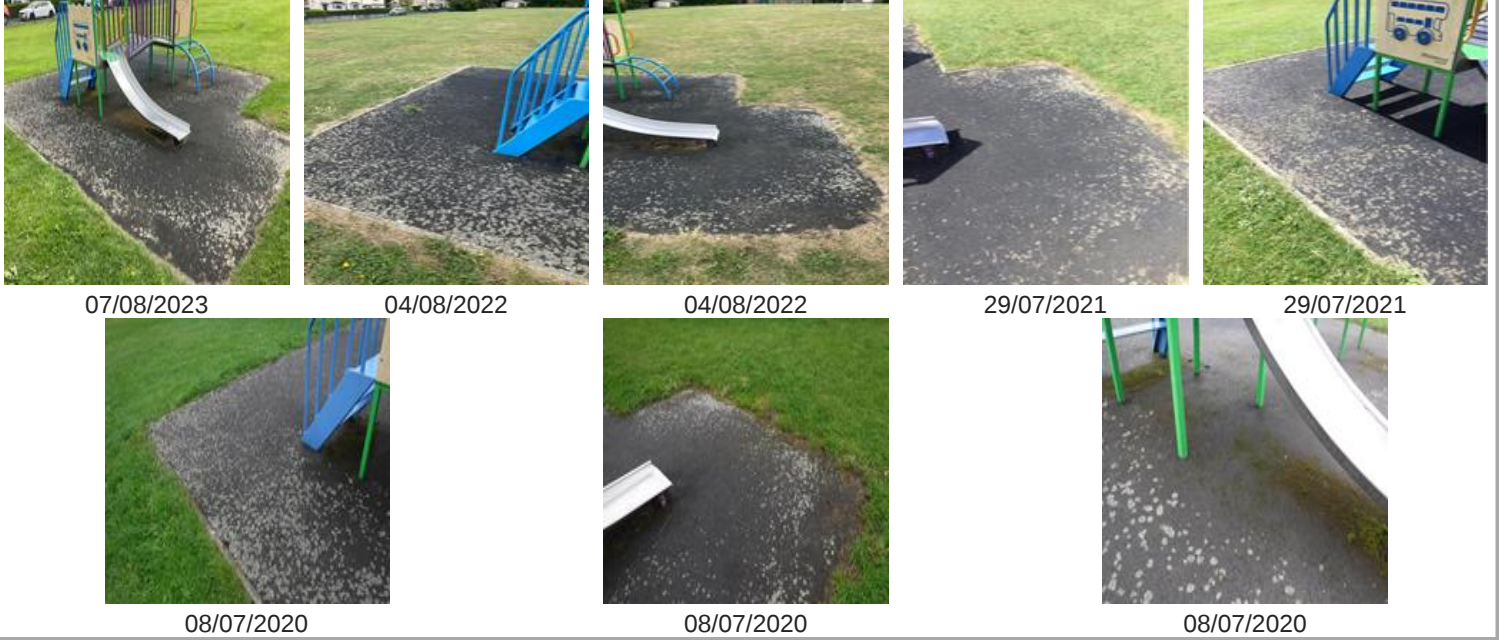
<b>Asset</b>	Multiplay Unit Toddler - Surface
<b>Finding Group</b>	Maintenance
<b>Finding Title</b>	Surface - Moss
<b>Standard Reference</b>	
<b>Standard Description</b>	Moss is present
<b>Finding Notes</b>	
<b>Cause</b>	Routine
<b>Finding Creation Date</b>	08/07/2020 12:13:00
<b>Risk Value Text</b>	1 x 3 = 3
<b>Risk Level</b>	Very Low
<b>Resolve By Date</b>	07/01/2021 12:13:00
<b>Finding Status</b>	Open

<b>Task Title</b>	Power Wash
<b>Task Notes</b>	
<b>Task Status</b>	Unapproved

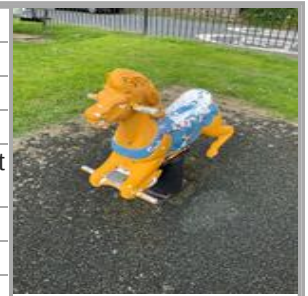
<b>Asset</b>	Rocker Horse
<b>Finding Group</b>	BS EN 1176:2017 Part 6 (Rockers - Playground)
<b>Finding Title</b>	Hand Supports and Foot Rests - Shape
<b>Standard Reference</b>	EN 1176:2017 - 6 - 4.6 and 4.7
<b>Standard Description</b>	When tested in accordance with EN 1176 the ends of the hand supports and foot rests do not comply with the requirements.
<b>Finding Notes</b>	
<b>Cause</b>	Manufacturer Defect
<b>Finding Creation Date</b>	08/07/2020 12:13:00
<b>Risk Value Text</b>	1 x 3 = 3
<b>Risk Level</b>	Very Low
<b>Resolve By Date</b>	08/07/2021 12:13:00
<b>Finding Status</b>	Open

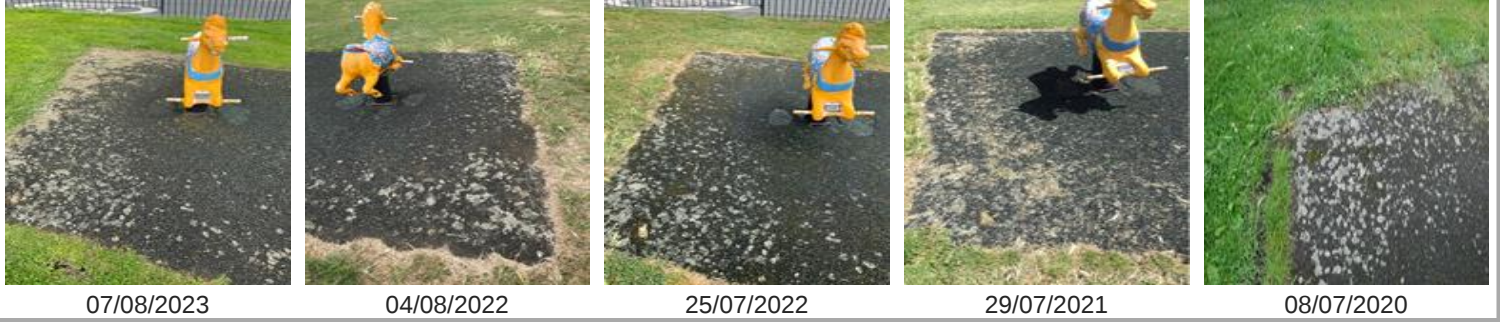
<b>Asset</b>	Rocker Horse - Surface
<b>Finding Group</b>	Maintenance
<b>Finding Title</b>	Surface - Moss
<b>Standard Reference</b>	
<b>Standard Description</b>	Moss is present
<b>Finding Notes</b>	
<b>Cause</b>	Routine
<b>Finding Creation Date</b>	08/07/2020 12:13:00
<b>Risk Value Text</b>	1 x 3 = 3
<b>Risk Level</b>	Very Low
<b>Resolve By Date</b>	07/01/2021 12:13:00
<b>Finding Status</b>	Open

<b>Task Title</b>	Power Wash
<b>Task Notes</b>	
<b>Task Status</b>	Unapproved

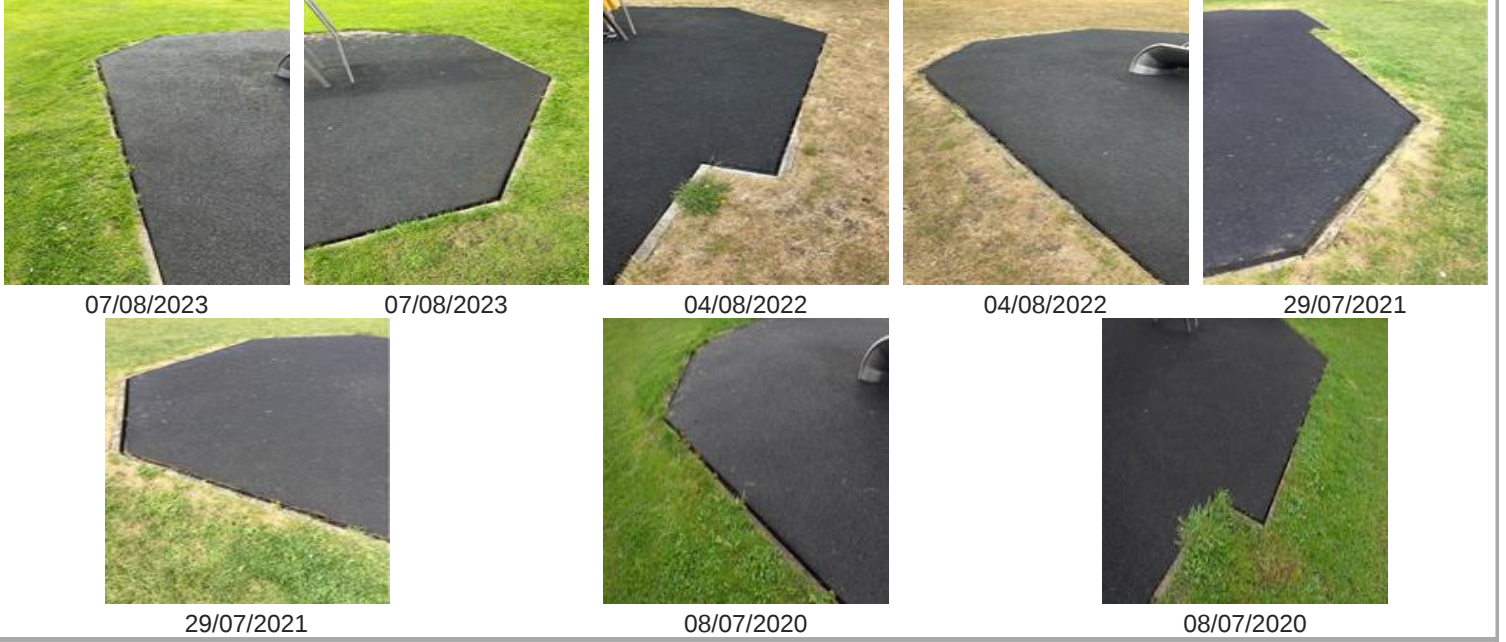
<b>Asset</b>	Slide Free Standing - Surface
<b>Finding Group</b>	Maintenance
<b>Finding Title</b>	Surface - Edges Shrunk
<b>Standard Reference</b>	
<b>Standard Description</b>	Surface - Edges Shrunk
<b>Finding Notes</b>	07.08.23 Condition deteriorated
<b>Cause</b>	Wear and Tear
<b>Finding Creation Date</b>	08/07/2020 12:13:00
<b>Risk Value Text</b>	3 x 3 = 9
<b>Risk Level</b>	Low
<b>Resolve By Date</b>	08/10/2020 12:13:00
<b>Finding Status</b>	Open

<b>Task Title</b>	Repair edges
<b>Task Notes</b>	
<b>Task Status</b>	Unapproved

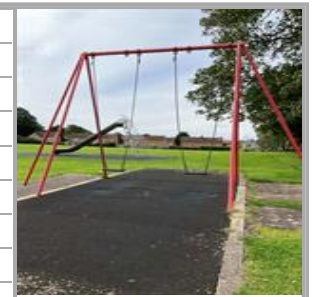
<b>Asset</b>	Swing - 1 Bay Flat Seat
<b>Finding Group</b>	Maintenance
<b>Finding Title</b>	Chain - Links Worn
<b>Standard Reference</b>	
<b>Standard Description</b>	Chains links worn
<b>Finding Notes</b>	
<b>Cause</b>	Wear and Tear
<b>Finding Creation Date</b>	08/07/2020 12:13:00
<b>Risk Value Text</b>	1 x 3 = 3
<b>Risk Level</b>	Very Low
<b>Resolve By Date</b>	08/07/2021 12:13:00
<b>Finding Status</b>	Open

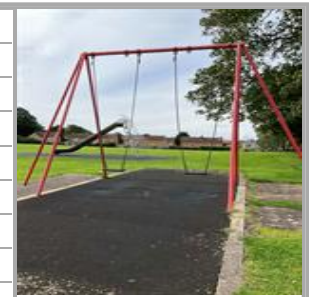
<b>Asset</b>	Swing - 1 Bay Flat Seat
<b>Finding Group</b>	Maintenance
<b>Finding Title</b>	Metal - Excessive Corrosion
<b>Standard Reference</b>	
<b>Standard Description</b>	Metal excessive corrosion
<b>Finding Notes</b>	
<b>Cause</b>	Wear and Tear
<b>Finding Creation Date</b>	08/07/2020 12:13:00
<b>Risk Value Text</b>	1 x 3 = 3
<b>Risk Level</b>	Very Low
<b>Resolve By Date</b>	08/07/2021 12:13:00
<b>Finding Status</b>	Open

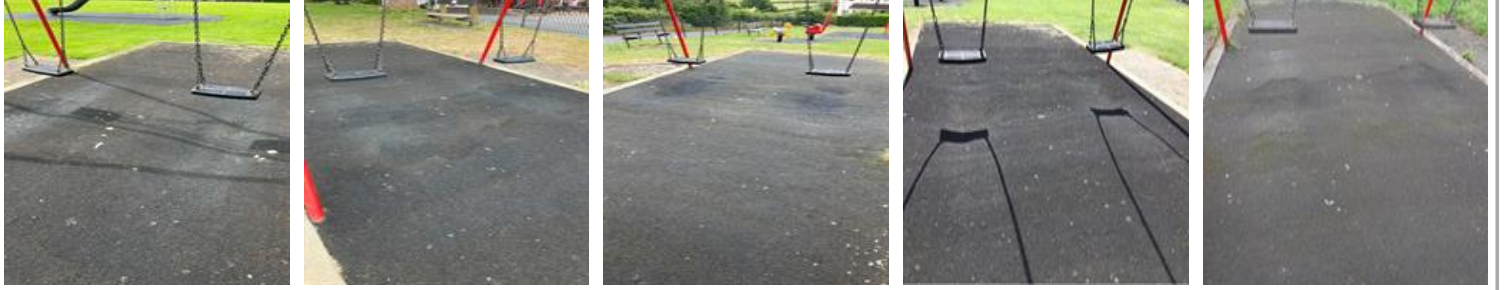
<b>Asset</b>	Swing - 1 Bay Flat Seat - Surface
<b>Finding Group</b>	Maintenance
<b>Finding Title</b>	Surface - Wearing
<b>Standard Reference</b>	
<b>Standard Description</b>	Surface wearing
<b>Finding Notes</b>	
<b>Cause</b>	Wear and Tear
<b>Finding Creation Date</b>	08/07/2020 12:13:00
<b>Risk Value Text</b>	1 x 2 = 2
<b>Risk Level</b>	Very Low
<b>Resolve By Date</b>	08/07/2021 12:13:00
<b>Finding Status</b>	Open

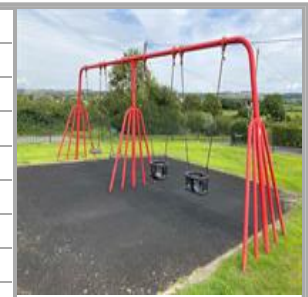
<b>Asset</b>	Swing - 2 Bay Mixed Seat
<b>Finding Group</b>	Maintenance
<b>Finding Title</b>	Swing - Chains twisted
<b>Standard Reference</b>	
<b>Standard Description</b>	Swing - Chains twisted
<b>Finding Notes</b>	
<b>Cause</b>	Poor Maintenance
<b>Finding Creation Date</b>	08/07/2020 12:13:00
<b>Risk Value Text</b>	1 x 1 = 1
<b>Risk Level</b>	Very Low
<b>Resolve By Date</b>	07/01/2021 12:13:00
<b>Finding Status</b>	Open

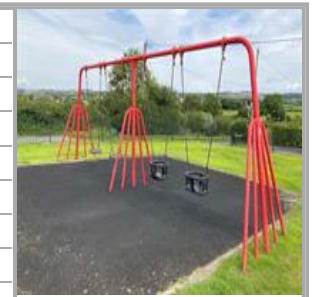
<b>Asset</b>	Swing - 2 Bay Mixed Seat
<b>Finding Group</b>	Maintenance
<b>Finding Title</b>	Chain - Cruxiform Connector(s) Worn
<b>Standard Reference</b>	
<b>Standard Description</b>	The cruxiform chain connector is worn.
<b>Finding Notes</b>	
<b>Cause</b>	Wear and Tear
<b>Finding Creation Date</b>	08/07/2020 12:13:00
<b>Risk Value Text</b>	1 x 3 = 3
<b>Risk Level</b>	Very Low
<b>Resolve By Date</b>	07/01/2021 12:13:00
<b>Finding Status</b>	Open

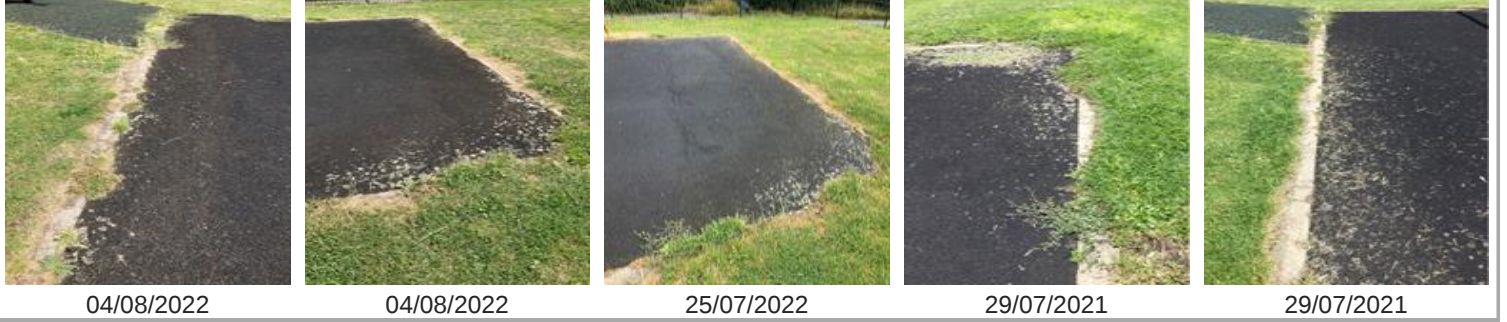
<b>Asset</b>	Swing - 2 Bay Mixed Seat - Surface
<b>Finding Group</b>	Maintenance
<b>Finding Title</b>	Surface - Weeds
<b>Standard Reference</b>	
<b>Standard Description</b>	Surface has unintended weeds
<b>Finding Notes</b>	
<b>Cause</b>	Routine
<b>Finding Creation Date</b>	29/07/2021 11:53:36
<b>Risk Value Text</b>	1 x 1 = 1
<b>Risk Level</b>	Very Low
<b>Resolve By Date</b>	13/01/2022 11:53:52
<b>Finding Status</b>	Open

<b>Task Title</b>	Remove weeds
<b>Task Notes</b>	
<b>Task Status</b>	Unapproved

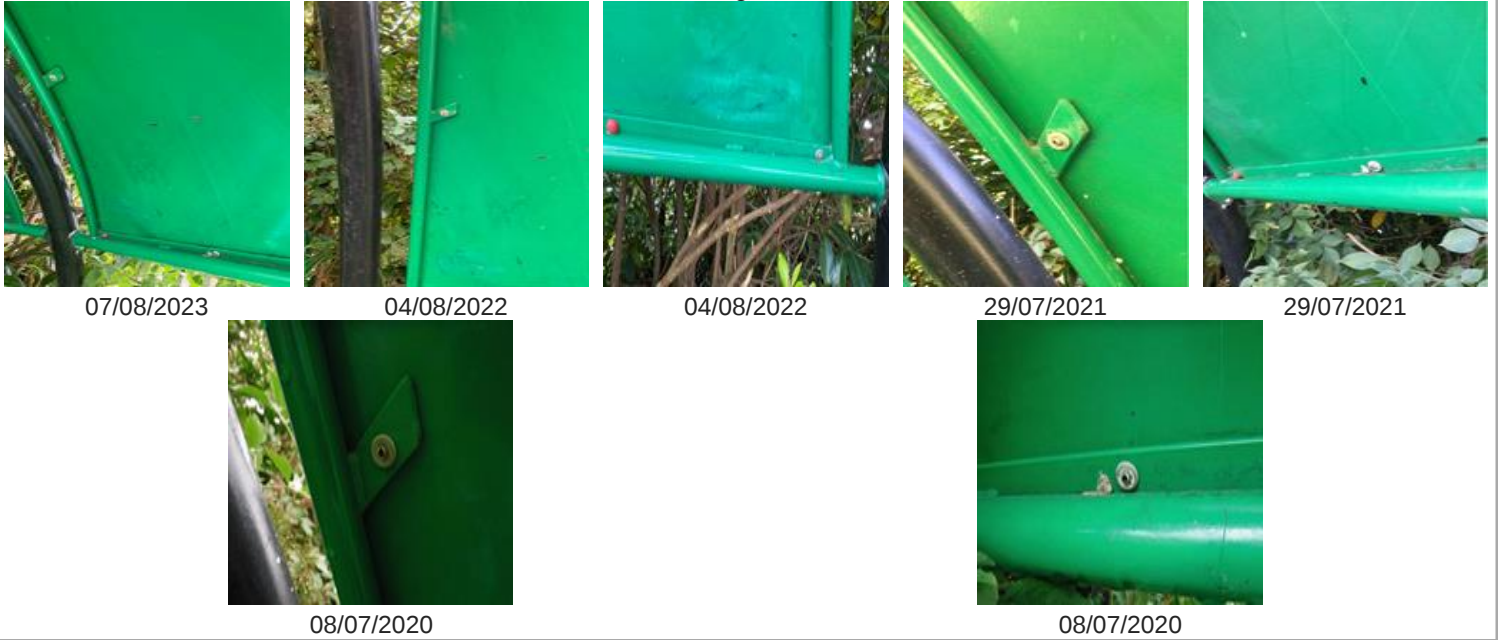
<p>Asset Photo</p>
Finding Group	Maintenance	
Finding Title	Item - Cap(s) missing	
Standard Reference		
Standard Description	Cap(s) missing	
Finding Notes		
Cause	Wear and Tear	
Finding Creation Date	08/07/2020 12:13:00	
Risk Value Text	1 x 2 = 2	
Risk Level	Very Low	
Resolve By Date	07/01/2021 12:13:00	
Finding Status	Open

Task Title	Replace
Task Notes	
Task Status	Unapproved

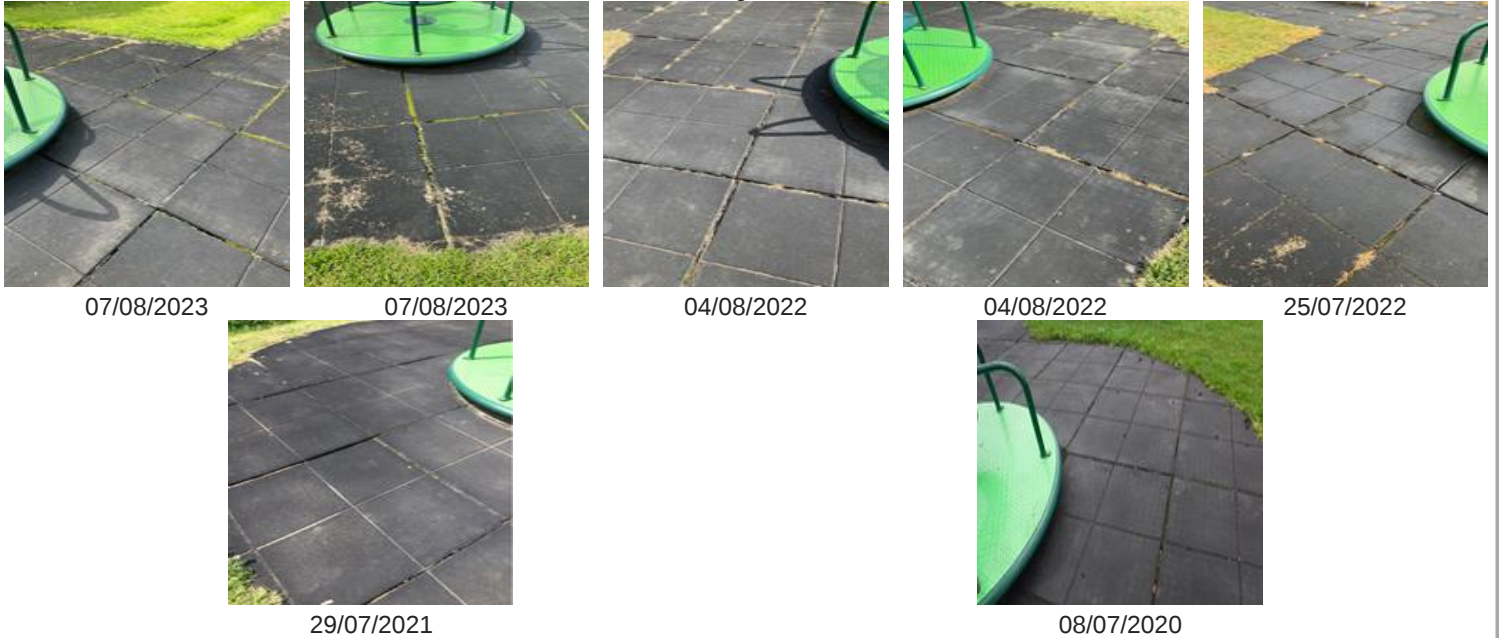
Asset	Carousel - Surface
Finding Group	Maintenance
Finding Title	Surface - Tiles - Gaps
Standard Reference	
Standard Description	Surface tiles with gaps between
Finding Notes	
Cause	Wear and Tear
Finding Creation Date	08/07/2020 11:25:00
Risk Value Text	1 x 3 = 3
Risk Level	Very Low
Resolve By Date	07/01/2021 11:25:00
Finding Status	Open

Task Title	Close / fill gaps
Task Notes	29.07.21 Gaps being filled at time of inspection 25.07.22 Some gaps remain
Task Status	Assigned

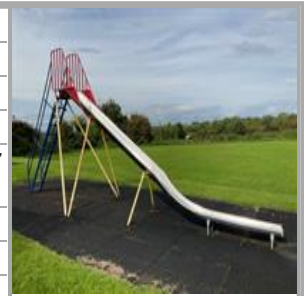
<b>Asset</b>	Slide Free Standing
<b>Finding Group</b>	BS EN 1176:2017 Part 1 (General - Playground)
<b>Finding Title</b>	EN1176:2017 - Part 1 - Compliance
<b>Standard Reference</b>	EN 1176:2017 - 1
<b>Standard Description</b>	The equipment does not comply with one or more requirements of EN 1176:2017 Part 1.
<b>Finding Notes</b>	
<b>Cause</b>	Manufacturer Defect
<b>Finding Creation Date</b>	08/07/2020 11:25:00
<b>Risk Value Text</b>	1 x 3 = 3
<b>Risk Level</b>	Very Low
<b>Resolve By Date</b>	08/07/2021 11:25:00
<b>Finding Status</b>	Open

<b>Task Title</b>	No action required, based on risk assessment, as asset pre-dates EN 1176
<b>Task Notes</b>	
<b>Task Status</b>	Unapproved

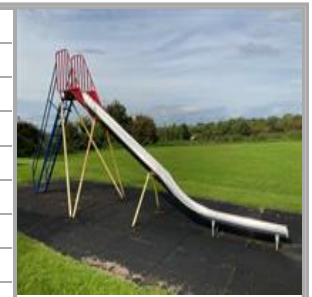
<b>Asset</b>	Slide Free Standing
<b>Finding Group</b>	Maintenance
<b>Finding Title</b>	Metal - Excessive Corrosion
<b>Standard Reference</b>	
<b>Standard Description</b>	Metal excessive corrosion
<b>Finding Notes</b>	
<b>Cause</b>	Wear and Tear
<b>Finding Creation Date</b>	08/07/2020 11:25:00
<b>Risk Value Text</b>	1 x 2 = 2
<b>Risk Level</b>	Very Low
<b>Resolve By Date</b>	08/07/2021 11:25:00
<b>Finding Status</b>	Open

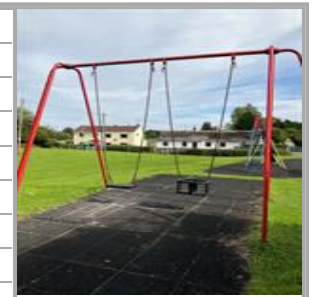
<b>Asset</b>	Swing - 1 Bay Mixed Seat
<b>Finding Group</b>	Maintenance
<b>Finding Title</b>	Swing - Chains twisted
<b>Standard Reference</b>	
<b>Standard Description</b>	Swing - Chains twisted
<b>Finding Notes</b>	
<b>Cause</b>	Poor Maintenance
<b>Finding Creation Date</b>	08/07/2020 11:25:00
<b>Risk Value Text</b>	1 x 1 = 1
<b>Risk Level</b>	Very Low
<b>Resolve By Date</b>	07/01/2021 11:25:00
<b>Finding Status</b>	Open

<b>Task Title</b>	Refit chains
<b>Task Notes</b>	
<b>Task Status</b>	Unapproved

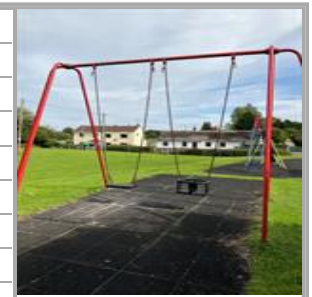
<b>Asset</b>	Swing - 1 Bay Mixed Seat
<b>Finding Group</b>	Maintenance
<b>Finding Title</b>	Chain - Links Worn
<b>Standard Reference</b>	
<b>Standard Description</b>	Chains links worn
<b>Finding Notes</b>	
<b>Cause</b>	Wear and Tear
<b>Finding Creation Date</b>	08/07/2020 11:25:00
<b>Risk Value Text</b>	1 x 3 = 3
<b>Risk Level</b>	Very Low
<b>Resolve By Date</b>	08/07/2021 11:25:00
<b>Finding Status</b>	Open

<b>Task Title</b>	Monitor
<b>Task Notes</b>	
<b>Task Status</b>	Unapproved

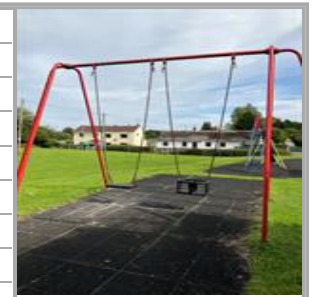
<b>Asset</b>	Swing - 1 Bay Mixed Seat
<b>Finding Group</b>	Maintenance
<b>Finding Title</b>	Chain - Cruxiform Connector(s) Worn
<b>Standard Reference</b>	
<b>Standard Description</b>	The cruxiform chain connector is worn.
<b>Finding Notes</b>	
<b>Cause</b>	Wear and Tear
<b>Finding Creation Date</b>	08/07/2020 11:25:00
<b>Risk Value Text</b>	1 x 3 = 3
<b>Risk Level</b>	Very Low
<b>Resolve By Date</b>	07/01/2021 11:25:00
<b>Finding Status</b>	Open

<b>Task Title</b>	Replace cruxiform connector(s)
<b>Task Notes</b>	
<b>Task Status</b>	Unapproved

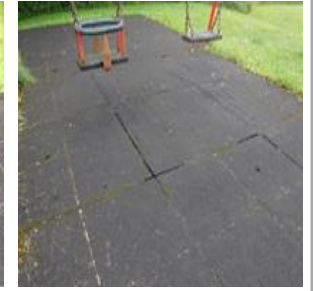
<b>Asset</b>	Swing - 1 Bay Mixed Seat - Surface
<b>Finding Group</b>	Maintenance
<b>Finding Title</b>	Surface - Wearing
<b>Standard Reference</b>	
<b>Standard Description</b>	Surface wearing
<b>Finding Notes</b>	
<b>Cause</b>	Wear and Tear
<b>Finding Creation Date</b>	08/07/2020 11:25:00
<b>Risk Value Text</b>	1 x 1 = 1
<b>Risk Level</b>	Very Low
<b>Resolve By Date</b>	08/07/2021 11:25:00
<b>Finding Status</b>	Open
